UNITED INSPECTION SERVICE
CONFIDENTIAL HOME INSPECTION FOR:

Client: Theresa Bechet
email: theresabeaudoin@yahoo.com
Date: August 12, 2016

Street Address: 164 W Bacon St
City / Town: Plainville, MA 02762
Weather: 90's Cloudy/Thunderstorm
Inspection Start Time: 3:45 PM
Inspection Stop Time: 6:00 PM

INSPECTOR: John Mushinsky

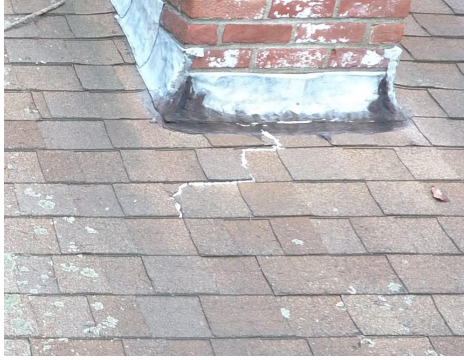
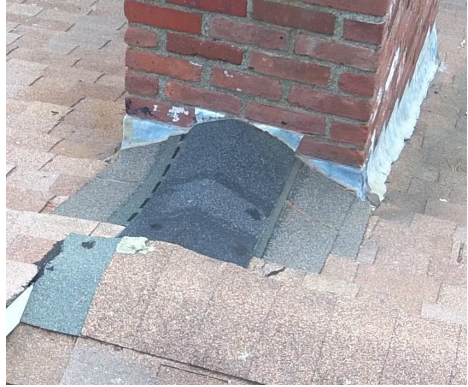
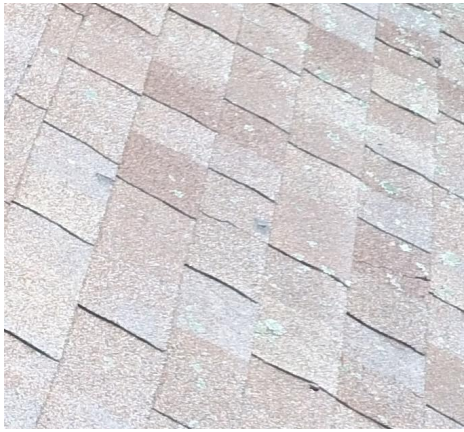
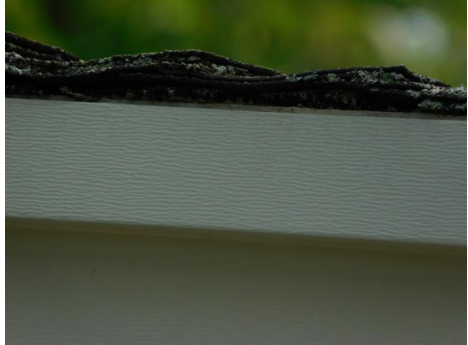
</div> <p>Several areas of roof shingle deterioration include:</p> <ul style="list-style-type: none"> • Split shingles • Torn/cracked shingles • Exposed roofing nails. • Organic growth. <p>Suspect active leakage. Interior ceilings and walls are water stained with elevated moisture levels.</p> <p>More than one layer of roof shingles are present on some roof sections. Anticipate additional cost for removal and disposal of existing roof shingles when repairs are required.</p> <p>Recommend a qualified roofing contractor evaluate the entire roofing system.</p>

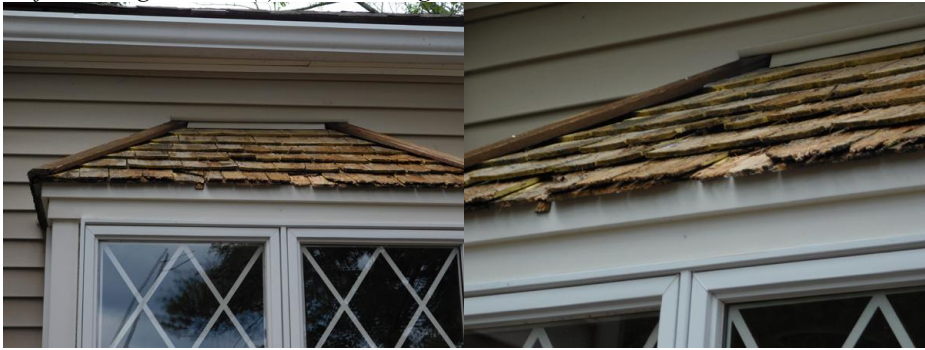
<p>Several areas of damaged/deteriorated/missing roof shingles. Suspect active leakage.</p>
<u>Roof Trim / Flashing</u>		X			<p>Most roof trim flashing is covered with metal wrap limiting readily observable areas.</p>
<u>Roof Drainage System</u>			X		<p><i>Roof Drainage System: Metal gutters/downspouts</i></p>

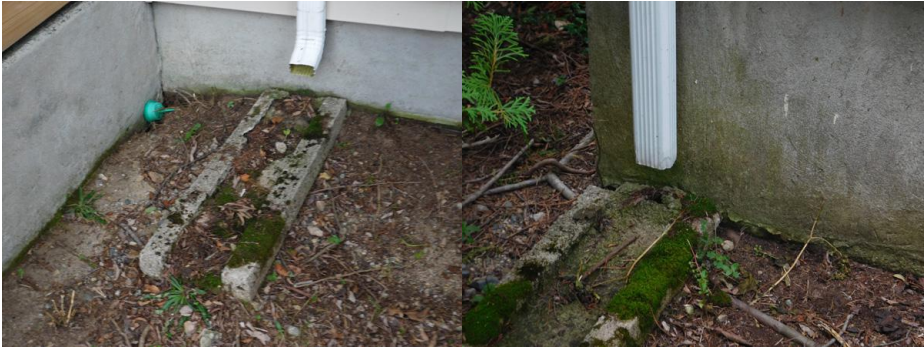
<p>Some downspouts draining at the foundation. Conductive condition for; basement water, foundation settlement, and wood destroying insects.</p>
<u>Chimney / Flashing</u>			X		<p><i>Chimney Material: Brick & Mortar</i></p>

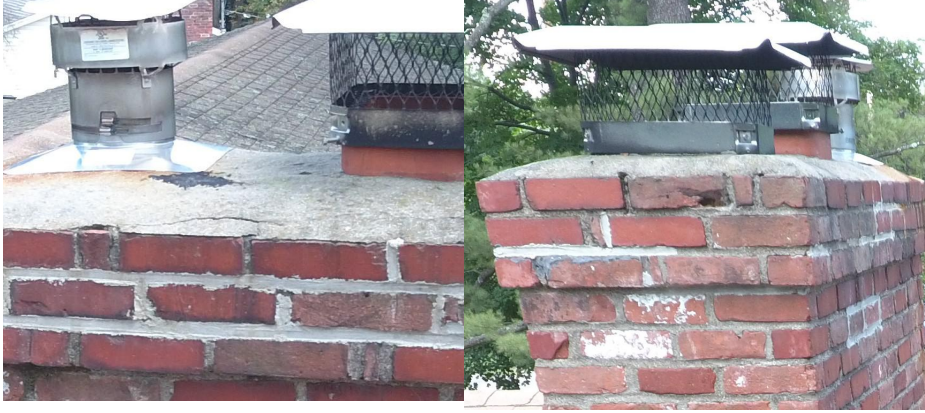
<p>Chimney crown is cracked. Some areas of damaged/deteriorated bricks.</p>

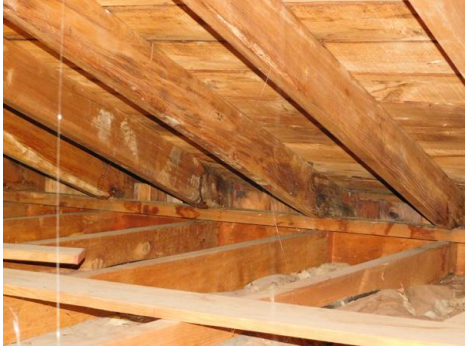
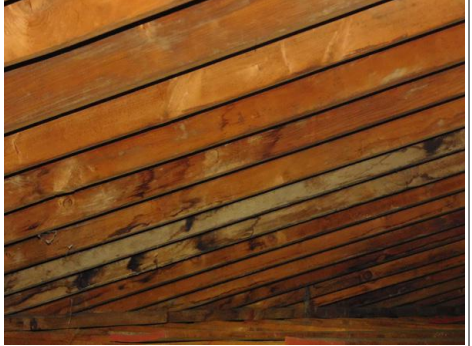
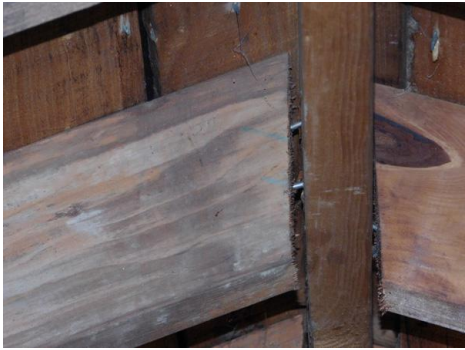
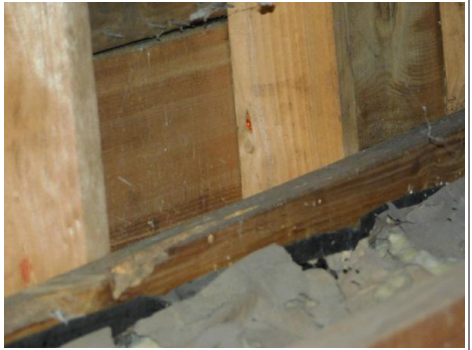
</div> <p>Absent attic flooring. Insufficient safe access to enter/traverse the attic. Observable area limited to the line-of-sight viewing angle from the attic scuttle.</p> <p>Water stains on rafters. Unable to safely access to probe/test moisture content. Suspect active leaks. Additional Investigation Required to confirm presence/absence of concealed damage and/or active water leak.</p> <p>Some rafters are pulling away from the ridge beam. Recommend a qualified contractor evaluate/re-enforce as required.</p> <p>Front right corner has an area of debris (frass), suspect from wood destroying insects. The floor joist along this area has signs of damage/deterioration. Unable to safely access to probe. Additional Investigation Required to confirm presence/absence of concealed damage.</p>

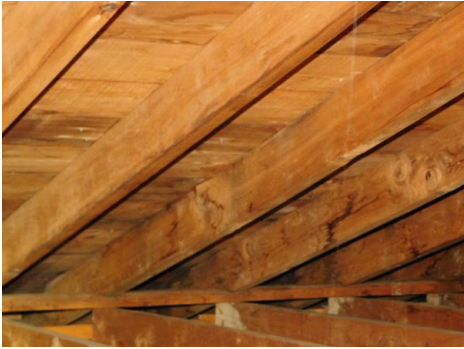
<p>Absent attic flooring. Insufficient safe access to enter/traverse the attic. Observable area limited to the line-of-sight viewing angle from the attic scuttle.</p> <p>Water stains on sheathing. Unable to safely access to probe/test moisture content. Suspect active leaks. Additional Investigation Required to confirm presence/absence of concealed damage and/or active water leak.</p>
<u>Attic Ventilation</u>			X		<p><i>Attic is vented with: Gable Vents, Soffit Vents</i></p>

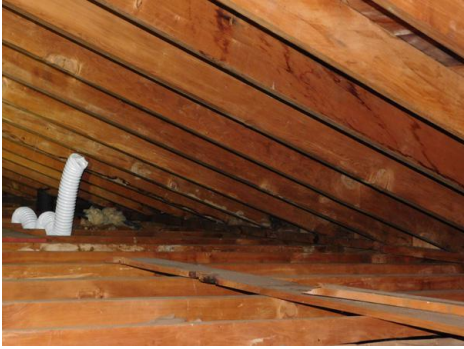
<p>Bathroom vent hose discharges directly into the attic. Bathroom vents discharging into unconditioned spaces can cause serious damage and/or mold in a short period of time.</p>

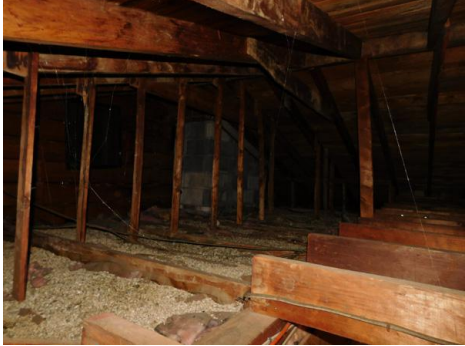
<p>Minimal insulation present. Recommend contact http://www.masssave.com for a free energy audit.</p> <p>Vermiculite insulation is used for attic insulation above breezeway. Some vermiculite may contain asbestos which is a health risk, SAFETY HAZARD. Additional Investigation Required to determine presence/absence of hazardous materials, asbestos. Recommend contact a qualified environmental contractor.</p>
Attic Flooring	X				No attic flooring.
Attic Light	X				No attic light.
Attic Inspection Method

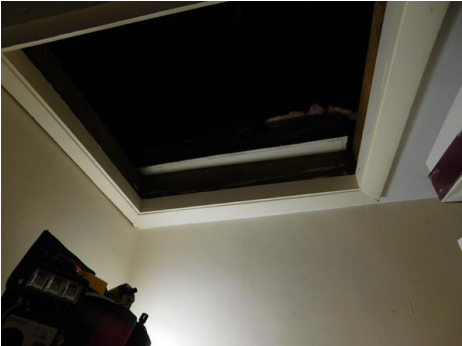
<p>Observe attic from a ladder at the scuttle in bedroom closet. Insufficient safe access. Attic not traversed.</p> <p>Portable 1,000 lumen light and zoom camera used during the inspection.</p>

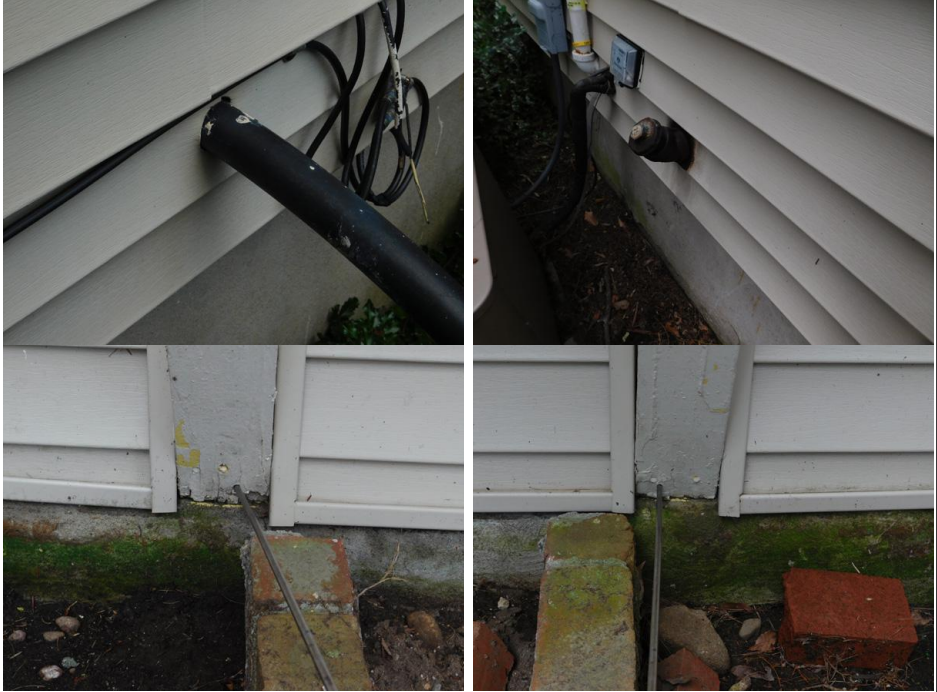
<p>Siding closer than 6 inches to grade, back between garage and main house. Conducive condition for wood destroying insects and wood decay.</p> <p>The wooden supports for the back bay window are damaged/deteriorated. Additional Investigation Required to confirm presence/absence of concealed damage.</p> <p>Unsealed penetration in the siding at the sump pump discharge hose, and oil fill/vent piping. Anticipate the risk of insect infestation and water penetration. Suspect previous and active leak. Additional Investigation Required to confirm presence/absence of concealed damage.</p>
GFCI Electric Receptacles		X			
Windows / Trim / Flashing			X		  <p>Kitchen casement window is stained/cloudy between the panes of glass indicating a broken seal and no longer performing as an insulated window.</p>

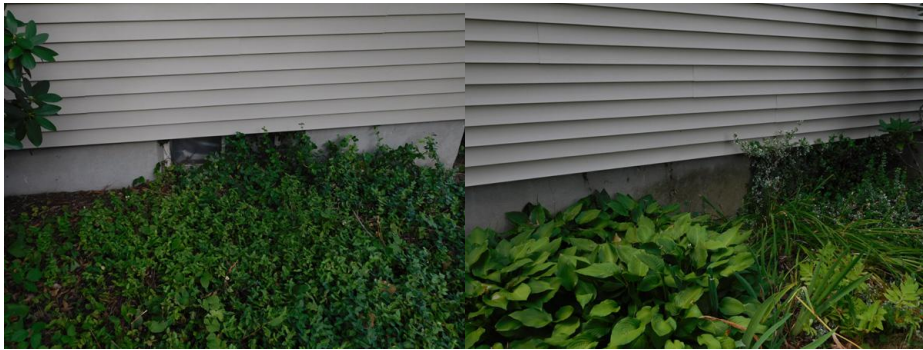
<p>Basement window sill at/near grade and covered with organic growth limiting observable areas. Anticipate the risk of moisture entry into the basement.</p>
Doors / Trim / Flashing			X		<p>Front handicap ramp blocks side entrance egress door. Anticipate the risk of insufficient emergency egress. SAFETY HAZARD.</p>
Steps / Stoops / Railings			X

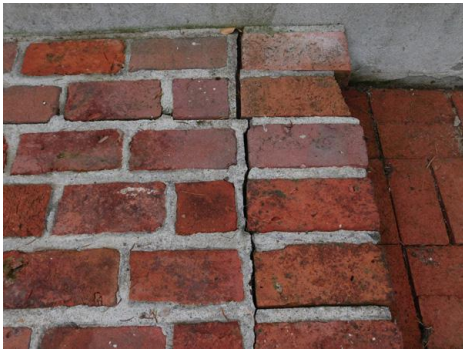
<p>Back step to garage has areas of damaged/deteriorated mortar joints.</p>
Walkways		X			
<u>Decks / Steps / Railings</u>	X				<i>Deck Materials: Not Present.</i>
<u>Porches / Steps / Railings</u>	X				<i>Porch Materials: Not Present.</i>
Balconies / Railings	X				N/A – Not Present.

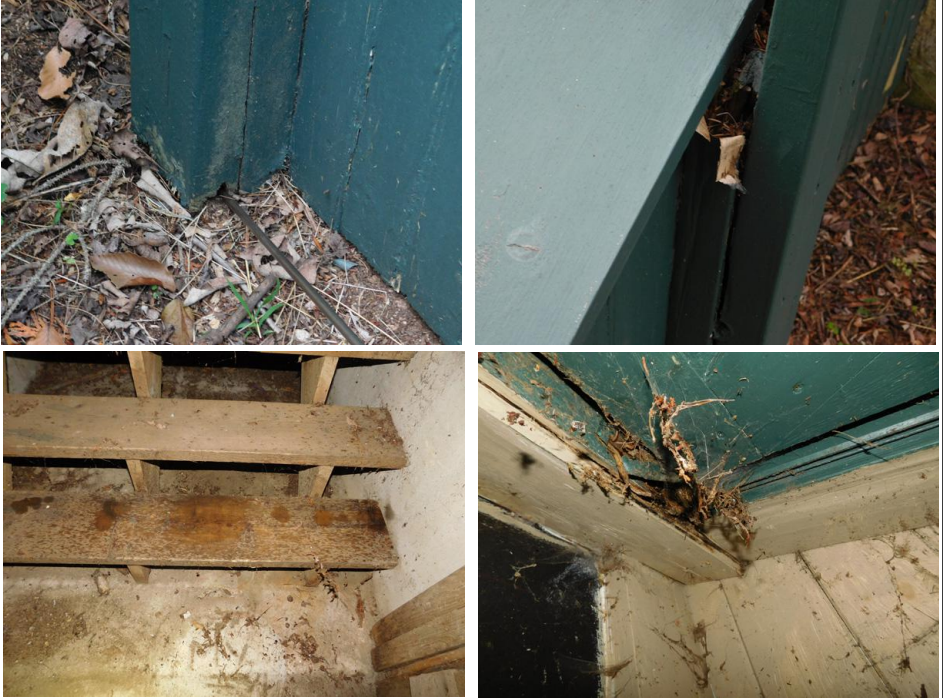
<p>Bulkhead is damaged/deteriorated with signs of wood destroying insects, carpenter ants, and actively leaking. Additional Investigation Required to determine presence/absence of concealed damage. Recommend contact a qualified pest control company.</p>
Driveways		X			
Vegetation			X		Vegetation in contact with house and overhanging trees. Conducive condition for insects.
Grading / Site Drainage			X		Negative slope grading in some areas. Conducive condition for; basement water, foundation settlement, and wood destroying insects.
Retaining Walls	X				N/A – No retaining walls adjacent to driveway/walkway.
Inspector Comments	<p>Anticipate the risk of deteriorating conditions with deferred maintenance/repair.</p> <p>Conducive conditions for wood destroying insects observed on the exterior:</p> <ul style="list-style-type: none"> • Unsealed penetrations in siding • Siding closer than 6 inches to grade • Vegetation in contact with the home • Negative slope grading, moisture accumulation at foundation • Downspouts draining at foundation, moisture accumulation at foundation <p>Recommend establishing and maintaining insect/pest treatment plan. Recommend researching insect/pest history with seller.</p>

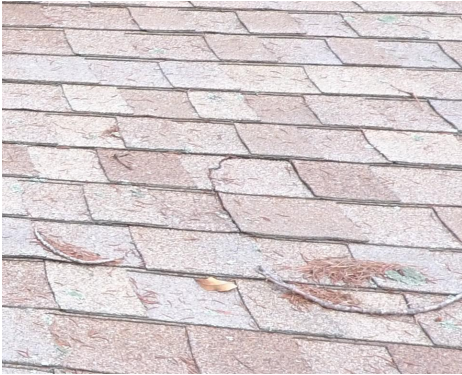
<p>Some areas of split roof shingles. Anticipate the risk of a leak in the near future.</p> <p>Significant areas of organic growth on roof shingles. Anticipate the risk of moisture seepage through the shingles.</p>
<u>Roof Trim / Flashing</u>		X			
<u>Roof Drainage System</u>			X		<p><u>Roof Drainage System: Metal gutters/downspouts</u></p>

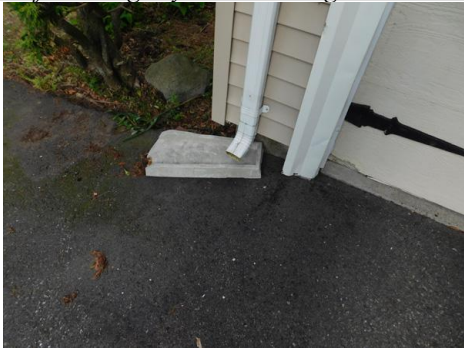
<p>Downspout draining at the foundation. Conducive condition for; basement water, foundation settlement, and wood destroying insects.</p>

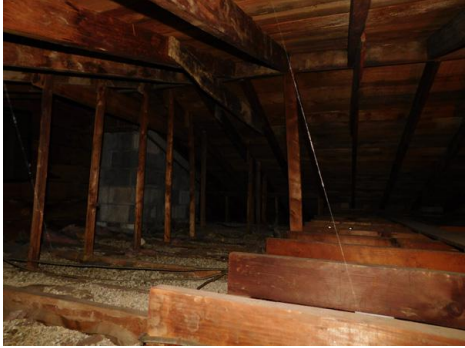
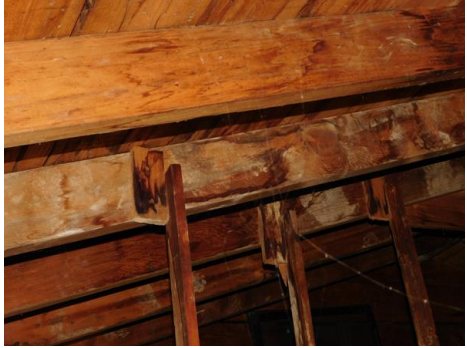
</div> <p>Water stains on rafters. Unable to safely access to probe/test moisture content. Suspect active leaks. Additional Investigation Required to confirm presence/absence of concealed damage and/or active water leak.</p> <p>Dark discolorations on rafters. Additional Investigation Required to confirm presence/absence of toxic mold.</p>
<u>Roof Sheathing</u>			X	X	<p><u>Sheathing Material: Dimensional lumber</u></p> <div style="display: flex; justify-content: space-around;">

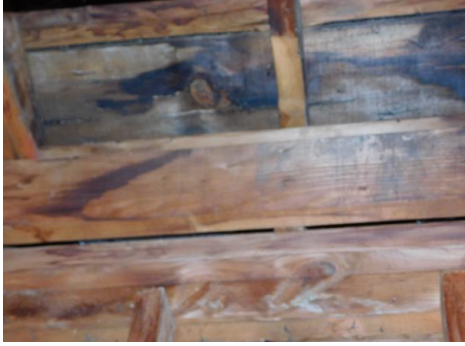
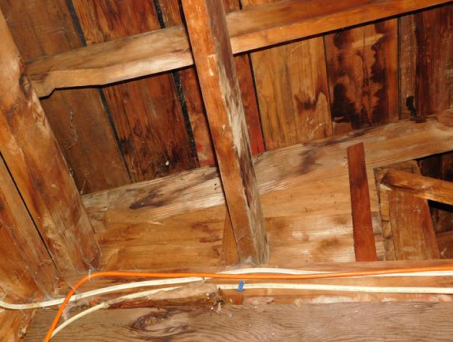
</div> <p>Water stains on sheathing. Unable to safely access to probe/test moisture content. Suspect active leaks. Additional Investigation Required to confirm presence/absence of concealed damage and/or active water leak.</p>

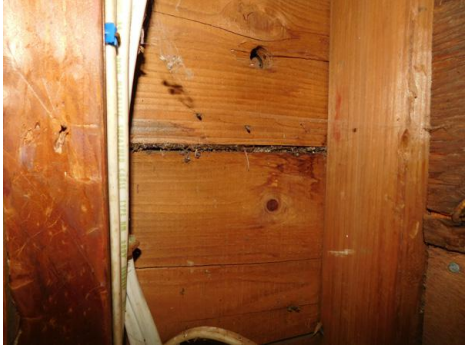
<p>Frass from wood destroying insects present between sheathing boards adjacent to back door. Additional Investigation Required to determine presence/absence of concealed damage.</p>
Dwelling to Garage Door			X

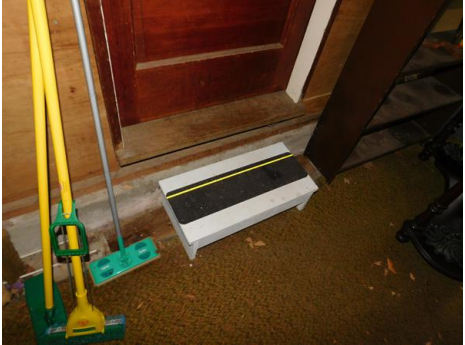
<p>Temporary step in place between garage and dwelling. SAFETY HAZARD. Non fire rated door between garage and dwelling. SAFETY HAZARD.</p>
<u>Siding / Trim</u>		X	X		<p><u>Siding Material(s): Vinyl</u> Siding closer than 6 inches to grade. Conducive condition for wood destroying insects. Additional Investigation Required to confirm presence/absence of concealed damage.</p>
GFCI Electric Receptacles		X			
<u>Garage Door + Operator</u>			X		<p><u>Optical Safety Device – Doors Automatically Reverse</u> <u>Pressure Safety Device – Doors Automatically Reverse</u></p>

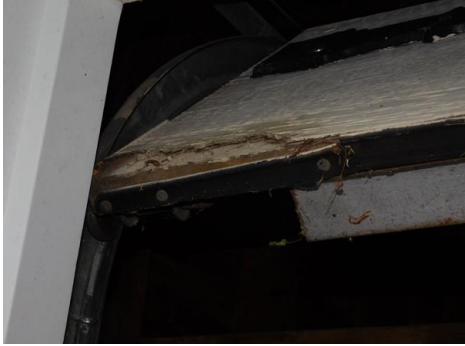
<p>Absent safety cords through garage door springs. Anticipate the risk of personal injury. SAFETY HAZARD. Lower edge of garage door and weather stripping is damaged.</p>

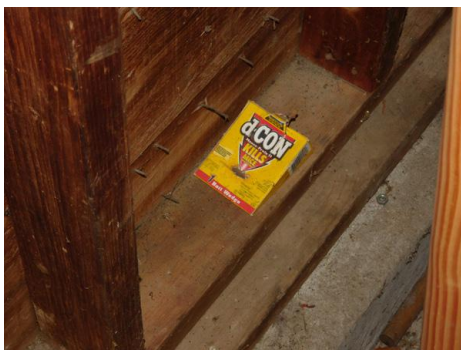
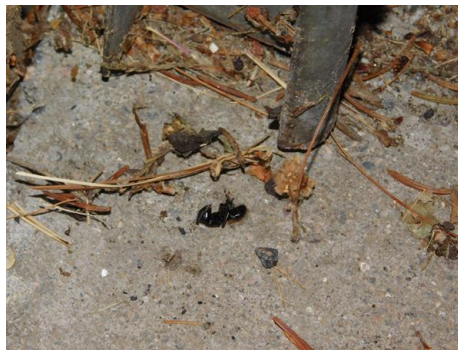
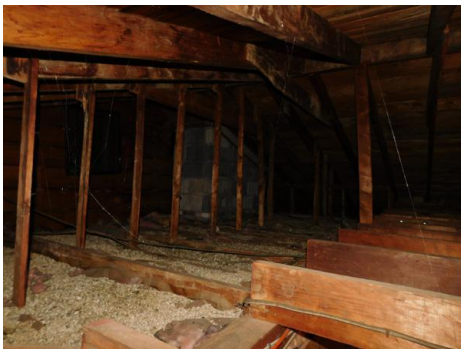
Anticipate the risk of deteriorating conditions with deferred maintenance/repair.

Dead carpenter ants observed around the garage door.

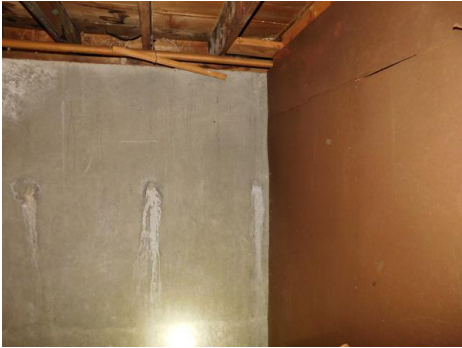
<p>Most foundation areas not observable, covered with finish materials.</p> <p>Water stains on some areas of basement walls. Previous water penetration. Additional Investigation Required to confirm presence/absence of active water penetration.</p>
<u>Basement/Crawl Space Floor</u>			X		<p><u>Floor Material: Concrete</u></p>

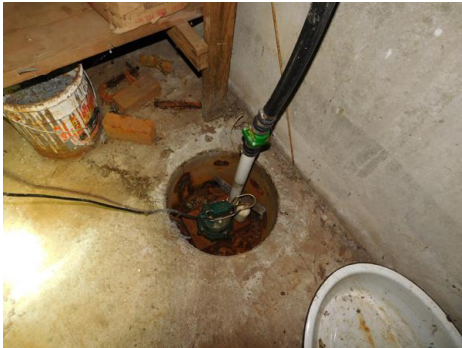
<p>Most areas of basement floor area not observable.</p> <p>Sump pump pit without a cover. Conducive conditions for insects/pests, biological pollutants, or Radon gas. Recommend testing for Radon during the winter months when the ground is frozen.</p>
<u>Girders</u>			X		<p><u>Girder Material: Wood Timber</u></p> <p>Some girder areas not observable. No observable signs of structural impairment.</p>

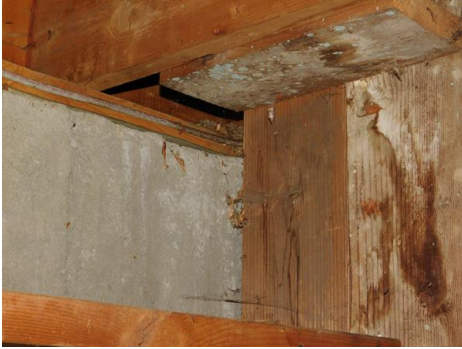
<p>Most sill areas not observable.</p> <p>Several areas of the sill are water stained. Additional Investigation Required to confirm presence/absence of active leak.</p> <p>The back right corner, behind shelving, has signs of wood destroying insects, frass. The front right corner behind the electrical panel has frass and some dead ants. Suspect concealed damage. Additional Investigation Required to determine presence/absence of concealed damage.</p>

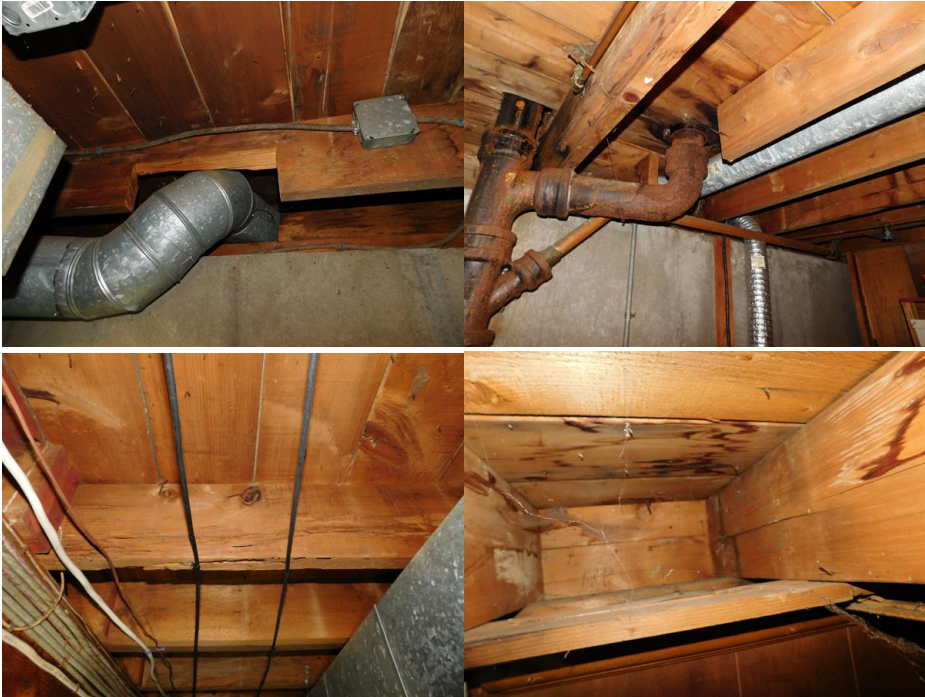
<p>Most floor joists areas not observable.</p> <p>Some floor joists are excessively notched and the a joist below the toilet is completely severed, insufficient structural support. Recommend a qualified contractor evaluate/repair as required.</p> <p>Floor joist in unfinished area adjacent to the girder has extensive damage from wood destroying insects, suspect termites. Additional Investigation Required to determine presence/absence of concealed damage. Recommend contact a qualified pest control company.</p> <p>A hole in the finished ceiling is present. The floor joist in this area is split at the end. Additional Investigation Required to determine presence/absence of concealed damage.</p>

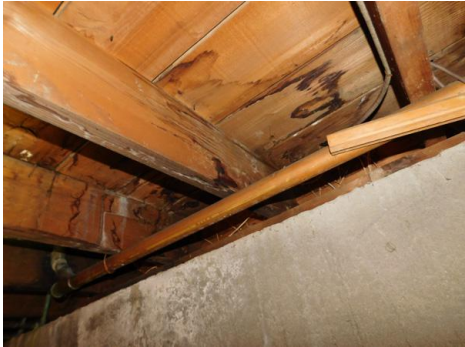
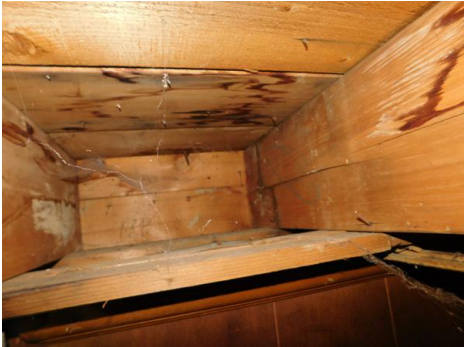
<p>Most sub floor areas not observable.</p> <p>Sub floor is water stained in several areas. The section between the furnace and oil tank is damaged/deteriorated. Additional Investigation Required to determine presence/absence of concealed damage.</p> <p>Unsealed penetrations through the sub floor around pipes/wires. Suspect insufficient fire protection. SAFETY HAZARD.</p>
<u>Columns / Posts</u>			X		<u>Column/Post Material: Filled Metal Columns</u>
<u>Ceiling Insulation</u>	X				<u>Ceiling Insulation Not Present</u>
<u>Crawl Space Ventilation</u>	X				<u>No crawl spaces</u>
Sump Pump			YES		MA Home Inspectors are prohibited from activating sump pumps. Recommend researching the age and condition of the sump pump with the seller.

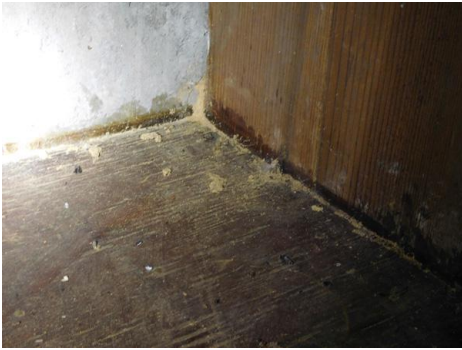
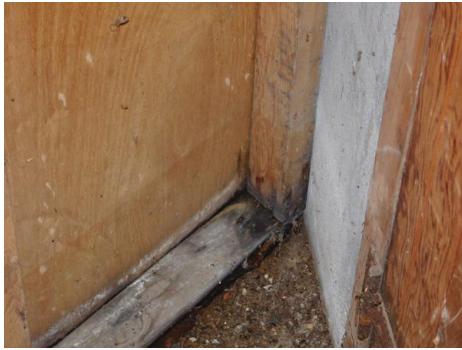
</div> <p>Shelves near bulkhead have signs of wood destroying insects, suspect termites.</p> <p>Wall sill plate adjacent to bulkhead is presently wet, over 20% moisture content, and is damaged/deteriorated. Additional Investigation Required to determine presence/absence of concealed damage.</p> <p>Significant amount of small animal debris present adjacent to electrical main panel. Additional Investigation Required to determine presence/absence of concealed damage.</p> <p>Poor/insufficient lighting in basement / crawlspace. Portable 1,000 lumen light and zoom camera used during the inspection.</p> <p>Recommend inquiring about previous and current pest and insect issues. Recommend establishing and maintaining an insect and pest treatment program.</p> <p>Unable to determine presence or absence of flood cleanup or other restoration. Recommend requesting C.L.U.E. (Comprehensive Loss Underwriters Exchange) Home Seller's Disclosure Report. http://www.lexisnexis.com/risk/solutions/clue-home-seller.aspx</p> <p>Several areas of rodent droppings observed and are known to carry hantavirus which can be fatal to humans. Use caution in cleaning rodent droppings. <i>Reference:</i> http://www.cdc.gov/hantavirus/</p>

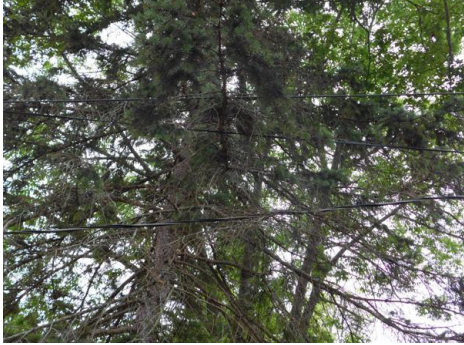
<p>Service lateral wires in contact with tree limbs. SAFETY HAZARD.</p>
<u>Electric Meter / Panel</u>				X

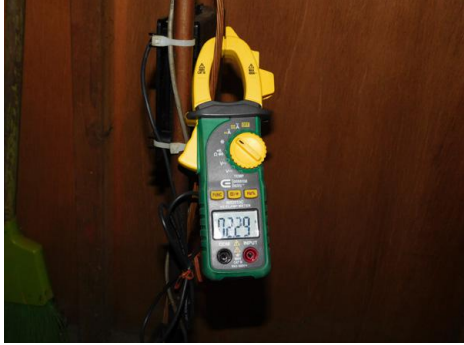
<p>Approximately 2.29 amps of current measured on the non-normal current carrying grounded conductor. Expect 0 amps. Additional Investigation Required by a qualified electrician to determine the scope of the repair(s).</p>

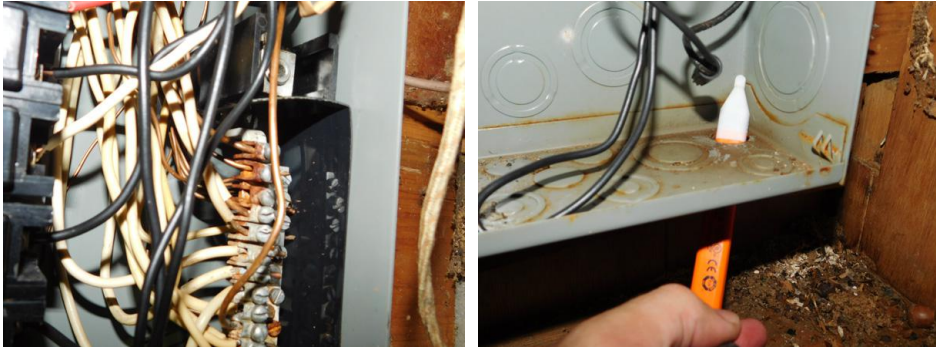
<p>Unsealed penetrations through the main panel. Anticipate the risk of personal injury. SAFETY HAZARD.</p> <p>Corrosion present inside the panel and on neutral/ground bus bar. SAFETY HAZARD.</p>
<u>Main Circuit Breaker / Fuse</u>			X		<p><u>Main Shut Off: 100 amp circuit breaker</u> <u>Wire Type Rating: Copper and Aluminum</u></p>
<u>Sub Panel</u>		X			<p><u>Sub panel is located in: NOT PRESENT</u> <u>Neutral bar isolated from panel: N/A</u> <u>Ground bar bonded to panel: N/A</u></p>
<u>Branch Circuit Wiring</u>				X	<p><u>Branch circuit wiring: Non-Metallic sheathed cable</u> <u>Branch circuit conductor(s): Copper, Stranded Aluminum</u></p>

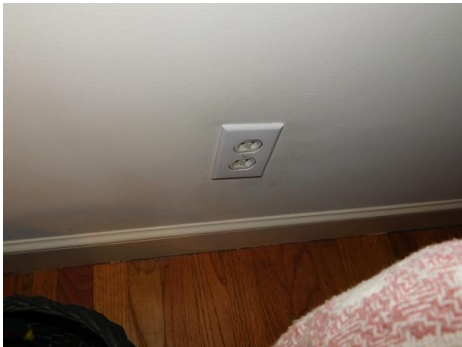
<p>Two conductor wiring without an equipment ground conductor. Anticipate the risk of personal injury. SAFETY HAZARD.</p>

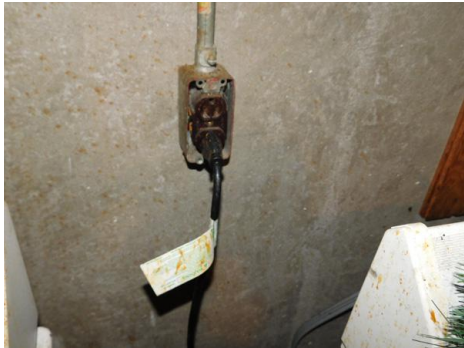
<p>Absent GFCI protection. Absent receptacle cover. Anticipate the risk of personal injury. SAFETY HAZARD.</p>
Unfinished Basement			X

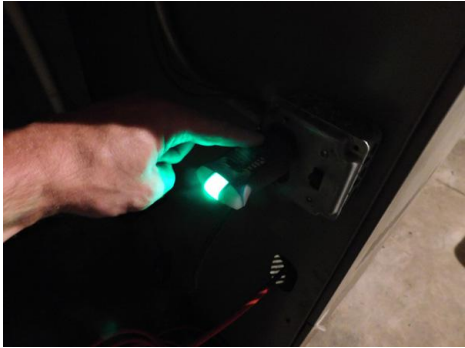
<p>Absent GFCI protection. Anticipate the risk of personal injury. SAFETY HAZARD.</p>
Inspector Comments	Recommend repair/upgrade to current electrical safety standards.

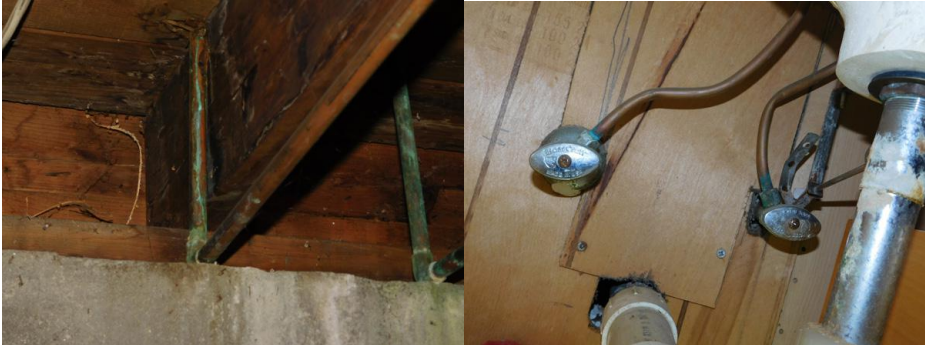
<p>Pin hole leak, green/white corrosion, at some valves and fittings. Anticipate the risk of a leak in the near future.</p>
WSD Pipe Supports			X		
WSD Pipe Insulation	X				N/A – No WSD piping in unheated areas of dwelling.
Fixtures				X

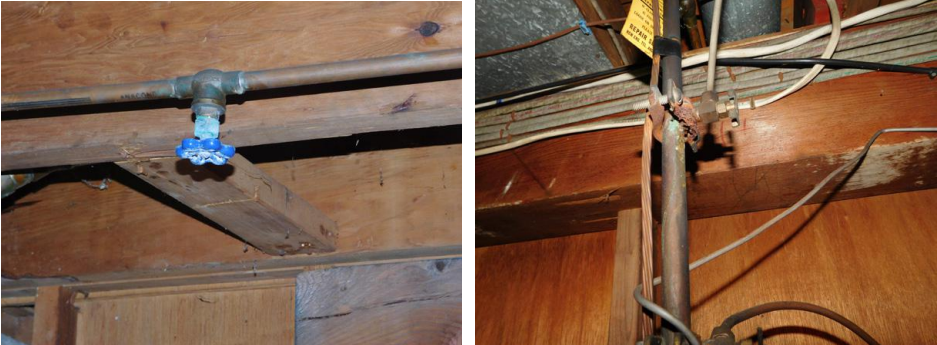
<p>Pin hole leak, green/white corrosion, at some valves and fittings. Anticipate the risk of a leak in the near future.</p>
Faucets				X

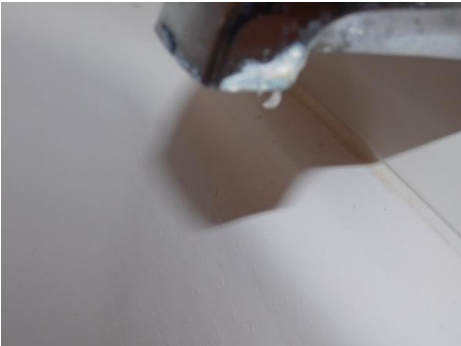
<p>Bathtub faucet drips after shut off.</p>
Functional Flow		X			
Signs of Previous Leaks			YES		<p>Pin hole leak, green/white corrosion, at some valves and fittings. Anticipate the risk of a leak in the near future.</p> <p>Water stains on sub floor around plumbing pipes.</p>
Signs of Active Leaks			NO		Additional Investigation Required to confirm presence/absence of active leak in areas of water stains around plumbing pipes.

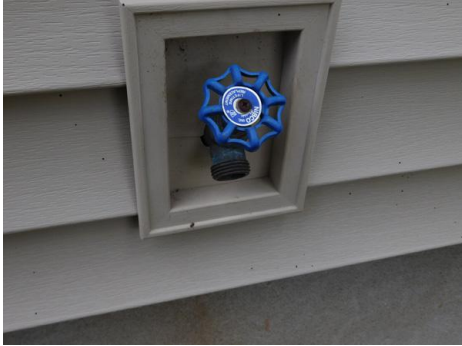
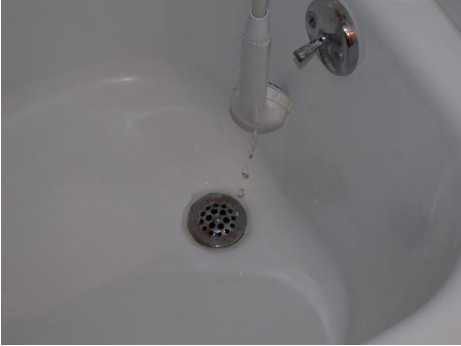
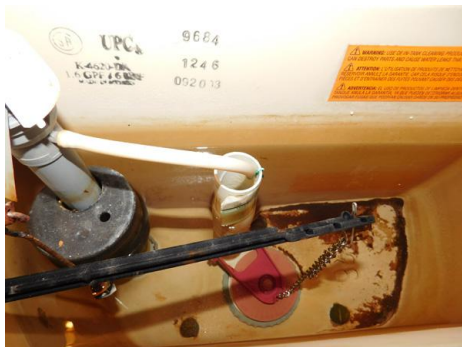
<p>Cross connection at exterior hose bib. SAFETY HAZARD. Absent vacuum breaker.</p> <p>Cross connection at bathtub/shower. SAFETY HAZARD. Extendable shower head remains below flood rim of tub when released. No visible ASSE 1014 rating.</p> <p>Cross connection at water closet (toilet tank). SAFETY HAZARD. Absent air gap between flush valve hose and toilet bowl tube. No visible ASSE 1002 rating.</p>
<u>Main Shut Off Location</u>					<u>Basement</u>
Inspector Comments					Anticipate the risk of deteriorating conditions with deferred maintenance/repair. Basement and under-sink valves were not operated during the inspection. Valve seals deteriorate over time. Recommend seller demonstrate all shut-off valves in good working condition. Anticipate possibility of leaks and repairs that may require a plumber. Recommend evaluation of the plumbing supply/distribution system by a qualified plumber. Recommend repair/upgrade to current plumbing safety standards.

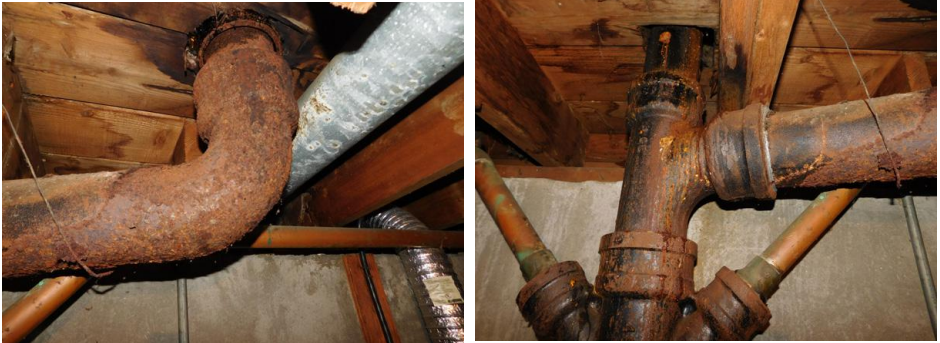
<p>Significant amount of corrosion on staining on the cast iron drain piping. Water is dripping at main vent connection where toilet connects, active leak. Recommend a qualified plumber evaluate/repair as required.</p>
DWV Pipe Supports		X			
DWV Pipe Insulation	X				N/A – No DWV piping in unheated areas of dwelling.
Drain / Trap			X

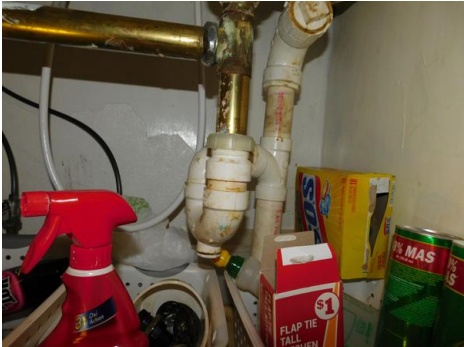
<p>Insufficient liquid seal, S-trap, at kitchen/bathroom drain. SAFETY HAZARD <i>Potential for sewer/septic gases to enter the home with loss of liquid seal from siphon effect of an S-trap.</i></p> <p>Rust/corrosion at some areas of the kitchen sink drain. Anticipate the risk of a drain leak in the near future.</p>
Drain Stop / Overflow			X

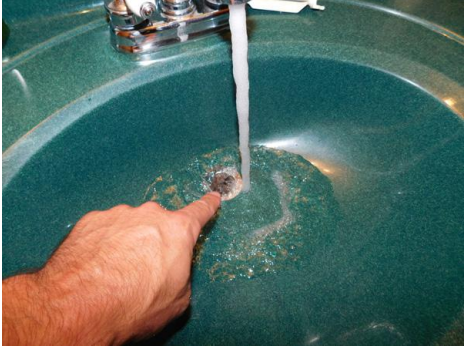
<p>Non-functional bathroom sink drain stop.</p>

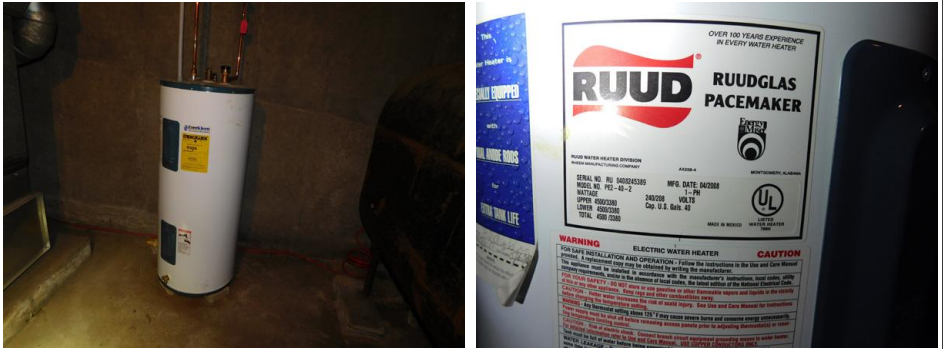
<p>Suspect the water heater is at/near the end of its service life. Fully depreciated. Anticipate the risk of repair/replacement in the near future. Recommend evaluation by a qualified plumber to determine/estimate the remaining service life of the water heater.</p>		
Hot Water Pipes / Supports		X					
Hot Water Pipe Insulation			X		Hot water pipes without insulation. Anticipate the risk of energy loss and higher operating costs.		
Thermostat / Mixing Valve			X

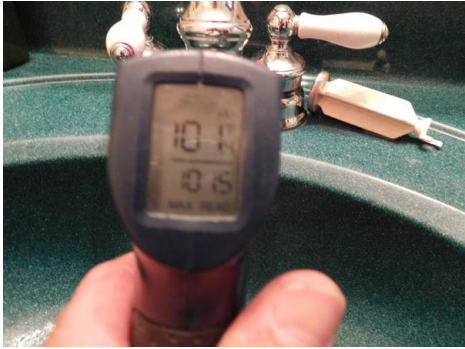
<p>MA Sanitary Code recommends hot water between 110F and 130F. Insufficient hot water temperature at the bathroom sink, approximately 102°F measured.</p>		
Chimney / Thimble	X				N/A – Electric water heater.

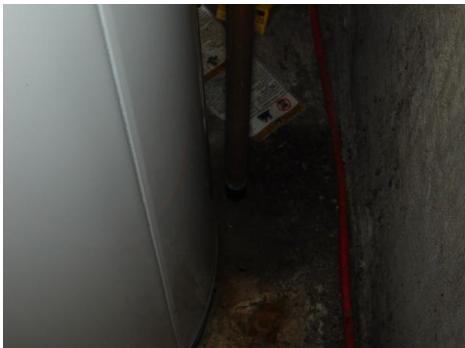
<p style="text-align: center;">Temperature pressure relief valve tailpipe is stained at the base and the floor below is water stained indicating leakage. Recommend a qualified plumber evaluate/repair as required.</p>
Vacuum Relief Valve		X			
Inspector Comments	Recommend transferring remaining water heater warranty. If there is no warranty, then the water heater is fully depreciated. Anticipate repair/replacement. Recommend checking water heater for safety recalls. Search for products on the Consumer Products Safety Commission website http://www.cpsc.gov/en/Recalls/

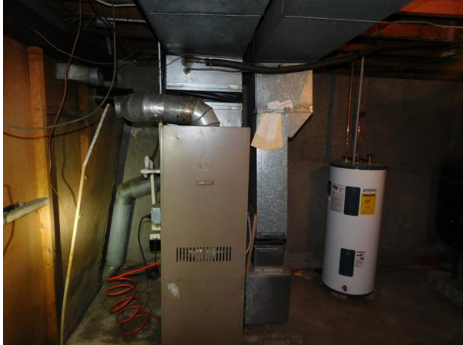
<p>Suspect the furnace is at/near the end of its service life. Fully depreciated. Anticipate the risk of repair/replacement in the near future. Recommend evaluation by a qualified HVAC technician to determine/estimate the remaining service life of the furnace.</p>
Burner			X	X

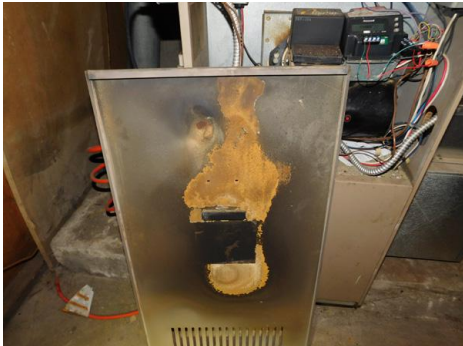
<p>Significant amount of soot staining on the interior cover of the furnace. Suspect flue gas back drafting, potential safety hazard. Recommend evaluation by a qualified HVAC technician to confirm presence/absence of proper combustion.</p>
Combustion Fan			X		
Condensate Drain / Pump	X				N/A – Non condensing furnace.

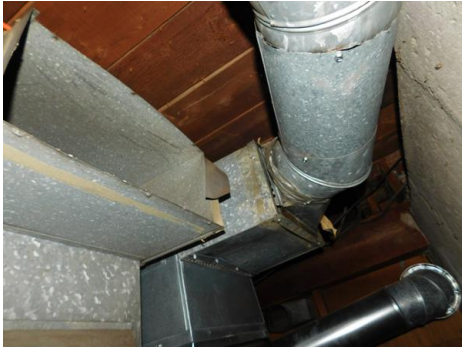
Absent end cover on the return HVAC duct.	
Blower Fan		X					
Air Filter			X

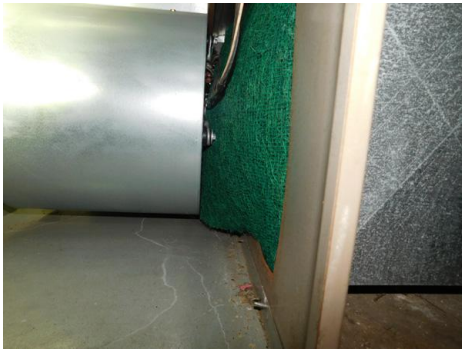
Air filter is distorted and pulled into the blower cabinet. Suspect un filtered air passing by air filter. Anticipate the risk of deterioration to heat exchanger.	
Dampers		X					
Registers		X					
Room Heat Source		X		X	Front small bedroom has minimal heat/air flow. Recommend a qualified HVAC technician evaluate/repair as required.		
Kitchen Heat Source		X					
Bathroom Heat Source		X					
Solid Fuel Appliance(s)	X				No solid fuel heating appliances observed.		
Inspector Comments	Recommend repair/upgrade to current heating safety standards. Recommend transferring remaining furnace warranty. If there is no warranty then the Central Furnace Heating System is fully depreciated. Recommend checking furnace for safety recalls. Search for products on the Consumer Products Safety Commission website http://www.cpsc.gov/en/Recalls/

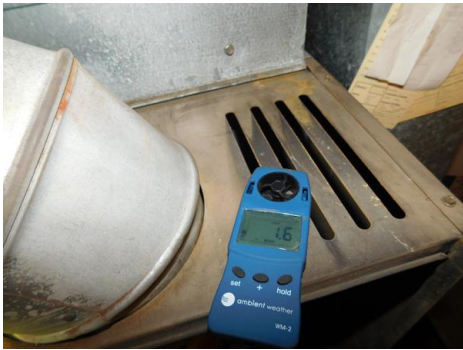
Conditioned air leaks at the top of the furnace. Anticipate the risks of reduced performance and higher operating costs.
Condensate Drain / Pump		X			
Normal Operating Controls		X			
<u>Distribution System</u>				X	<u>Distribution system is: Rigid metal ducts</u>

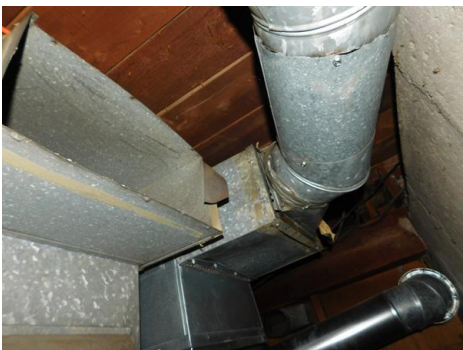
Absent cover on return duct.
Fans		X			
Ducts		X			
Duct Insulation			X		Absent insulation on A/C ducting. Anticipate the risk of damage to surrounding components due to condensation. Recommend ducts be insulated.
Supports		X			
Dampers		X			
Registers		X

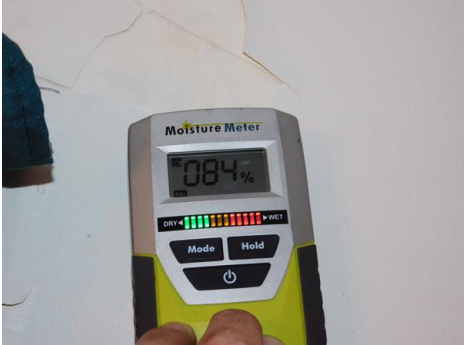
</div> <p>Cedar closet ceiling/wall is water stained. All areas tested with moisture meter are presently dry, previous leak.</p> <p>The bathroom wall is damaged/deteriorated/cracked and has high moisture content indicating active leakage. Additional testing required to determine presence/absence of concealed damage and/or mold.</p>
<u>Ceiling</u>			X	X	<p><u>Ceiling materials: Drywall, Plaster</u></p> <div style="display: grid; grid-template-columns: 1fr 1fr; gap: 5px;">

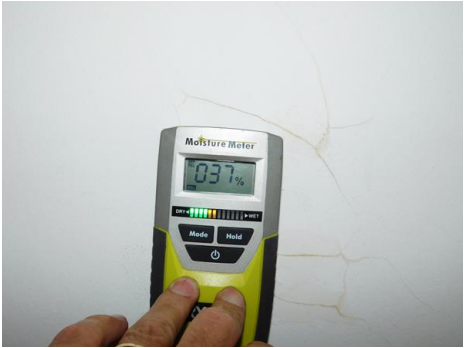
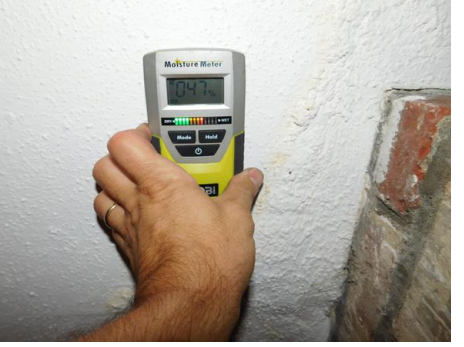
</div> <p>Water stains and high moisture meter measurements at some ceiling areas, basement along front wall, front small bedroom, bathroom, dining room, kitchen, and breezeway adjacent to chimney. Additional testing required to determine presence/absence of concealed damage and/or mold.</p>

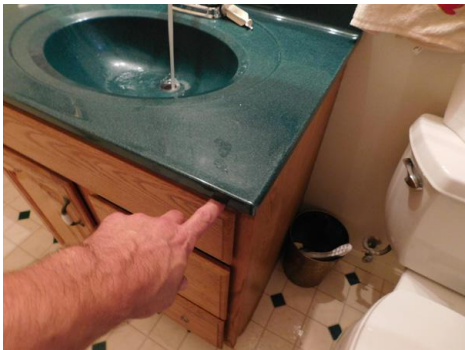
<p>Bathroom sink counter top is loosely secured.</p>
Rep. # Cabinets		X			
Rep. # Doors			X		Front handicap ramp blocks side entrance egress door. Anticipate the risk of insufficient emergency egress. SAFETY HAZARD.
Rep. # Windows			X

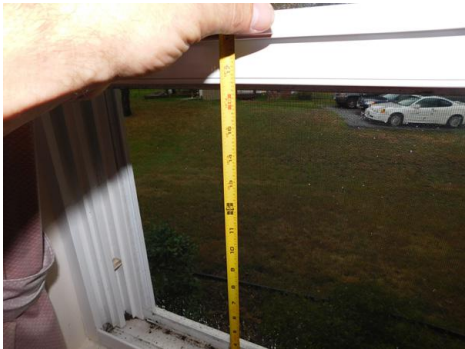
<p>Insufficient emergency egress at bedroom windows. SAFETY HAZARD. Window opening less than 20"x24".</p>
Kitchen Ventilation		X			
Bathroom Ventilation			X		Bathroom ventilation fan discharges into the attic. Bathroom vents discharging into unconditioned spaces can cause serious damage and/or mold in a short period of time.
Laundry Ventilation		X			
Fireplace / Hearth			X

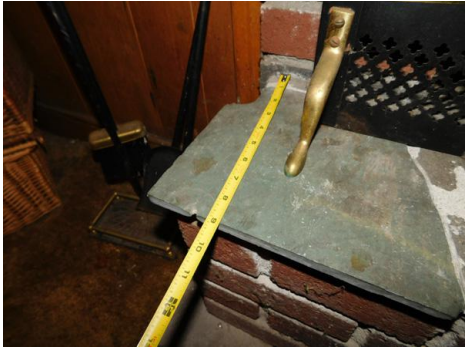
<p>Basement fireplace, Insufficient front clearances to combustibles around fireplace, less than 16". SAFETY HAZARD.</p> <p>First floor fireplace bricks are cracked. Recommend contact a qualified mason to evaluate/repair as required.</p>
