Property Conditions Report

14 Deer Foot Trail
Harvard, Massachusetts 01541

20:20 August 16, 2016

Cummings Trust
14 Deer Foot Trail
Page 1 of 41

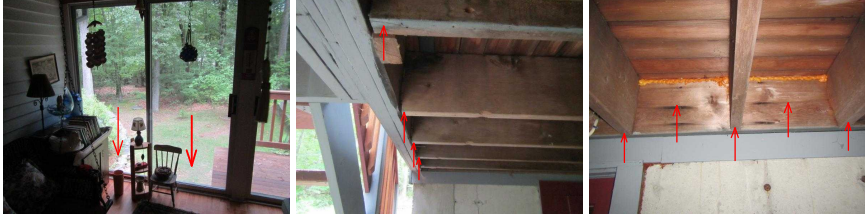
9. Porch: Rear three season porch - **Missing platform (stoop) at left hand sliding glass door. Missing lag bolts at ledger board. Missing joist hangers at ledger boards. A qualified contractor is recommended to evaluate and estimate repairs.**

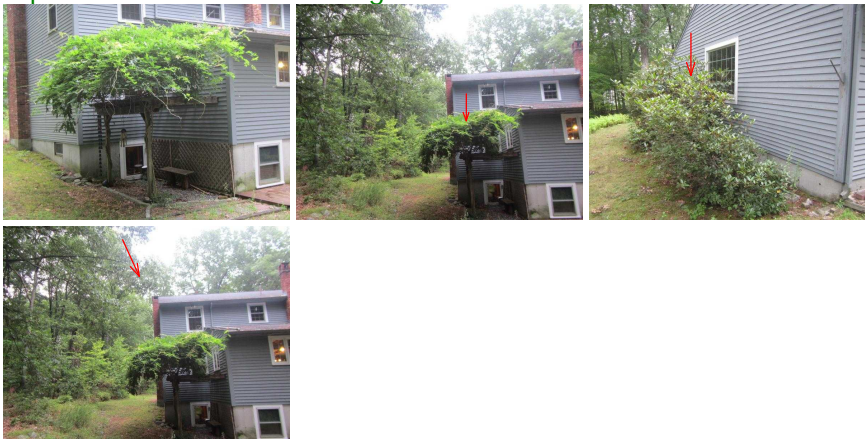
13. Balcony: Not present
 14. Grading: Flat, Moderate slope
 15. Swale: Not present
 16. Vegetation: Shrubs, Trees, Vines - **Remove vegetation in contact or capable of coming in contact with the dwelling. A qualified contractor is recommended to evaluate and estimate repairs. Tree limbs over hang the roof and should be cut back.**

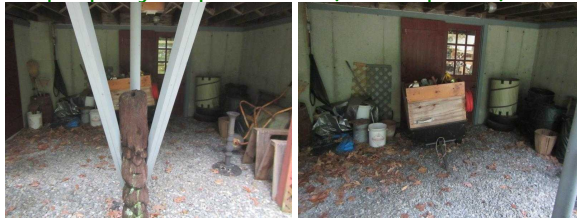
24. Lawn Sprinklers: Not present
25. Additional Comments: Lots and grounds - **Debris at or around property and grounds should be properly disposed of. (Under porch).**

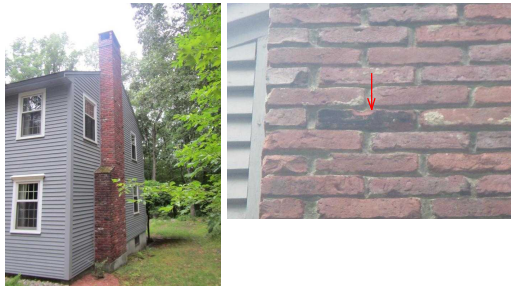
Right side Chimney

29. Chimney: Brick - **Bricks have broken or popped surfaces. Recommend monitor. A qualified contractor is recommended to evaluate and estimate repairs as or if needed.**

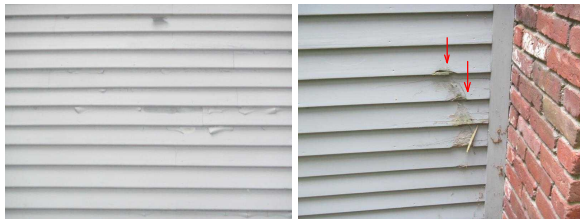
Front, rear, left and right Exterior Surface

1. Type: Wood - Cracked, chipped, peeling paint. Water damage at right side. A qualified contractor is recommended to evaluate and estimate repairs as needed.

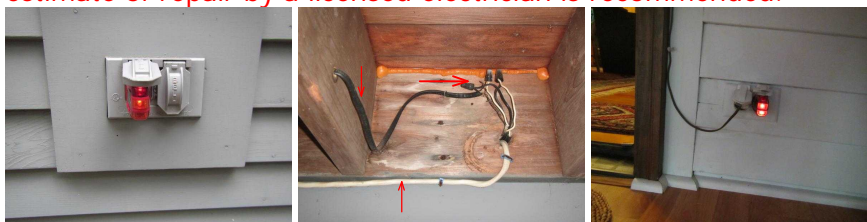
13. Screen Doors: Sliding at porch
14. Windows: Wood double hung, Wood casement
15. Storm Windows: Not present
16. Window Screens: Metal
17. Basement Windows: Aluminum slider, Wood casement
18. Exterior Lighting: Surface mount
19. Exterior Electric Outlets: 120 VAC receptacles - **Improperly wired at front outlet. Non-GFCI protected outlet circuits exterior front and rear porch. Recommend GFCI protected outlet circuits be installed. Improper wiring under rear porch, open splice is not contained inside of a junction box. All exterior wiring should be contained inside of conduit pipe. Evaluation and estimate of repair by a licensed electrician is recommended.**

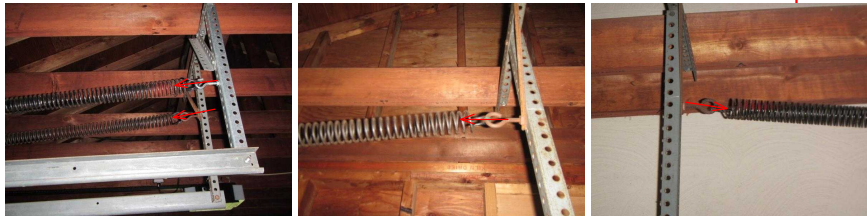
2. Garage Doors: Hardboard - Missing safety cables at overhead door springs. A qualified contractor is recommended for evaluation and estimate of repair.

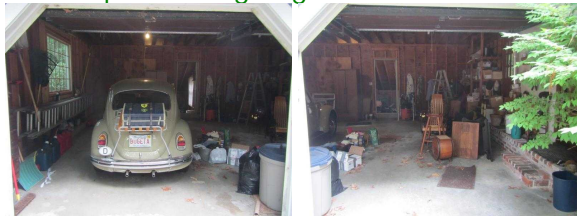
19. Smoke Detector: Not present - **Not tested, Fire Marshall to inspect, Certificate of compliance required from home owners at closing.**
 20. Heating: Not present
 21. Windows: Fixed glass left side
 22. Gutters: Not present
 23. Downspouts: Not present
 24. Leader/Extensions: Not present
 25. Additional comments Garage interior - **Stored items around interior perimeter of garage and vehicle parked in garage limit observation of foundation, floor surface and walls.**

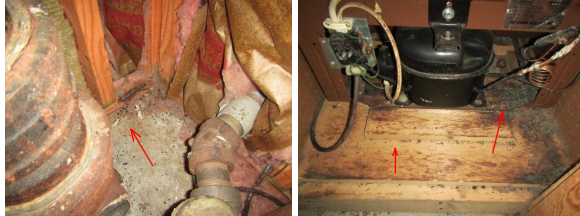
21. Additional comments Basement area - Evidence of past and/or present rodent activity (mice) at the time of inspection, recommend further review by a licensed pest control company for seasonal treatment as needed.

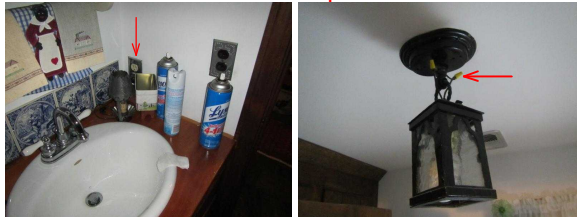
7. Electrical: 120 VAC outlets and lighting circuits - **Non-GFCI protected outlet circuit. Recommend GFCI protected circuit be installed. Improperly wired ceiling light fixture. Wire splice is not contained inside of a junction box. A licensed electrician is recommended to evaluate and estimate repairs.**

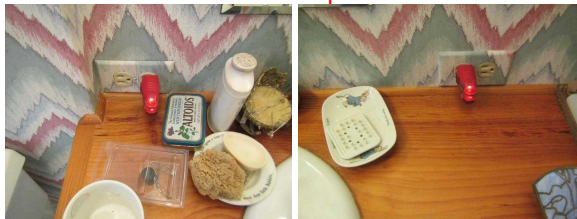
34. Closet: Clothing closet, cabinet shelving
 35. Closet: Cabinet shelving
 36. Ceiling: Plaster and/or Sheetrock
 37. Walls: Ceramic tile, Wallpaper
 38. Floor: Ceramic tile
 39. Doors: Interior solid wood
 40. Windows: Wood double hung
 41. Electrical: 120 VAC outlets and lighting circuits - **Non-GFCI protected outlet circuits. Recommend GFCI protected circuits be installed. A licensed electrician is recommended to evaluate and estimate repairs.**

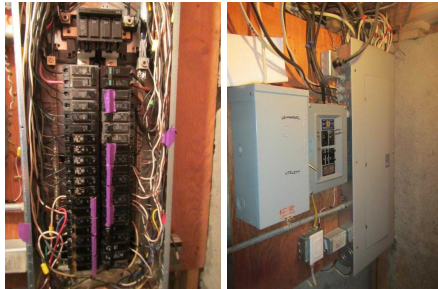
Basement Electric Panel

9. Manufacturer: General Electric

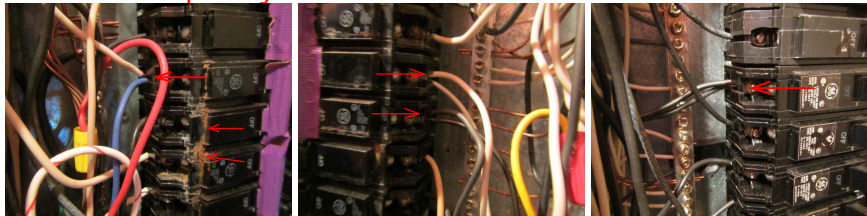
10. Maximum Capacity: 200 Amps
11. Main Breaker Size: 200 Amps
12. Breakers: 40 breakers
13. Fuses: Not present
14. Branch Circuits: 44 branch circuits - **Double tapped service breakers are present inside of the main electrical service panel. Corrosion is present on service breakers. Evaluation and estimate of repair by a licensed electrician is recommended.**

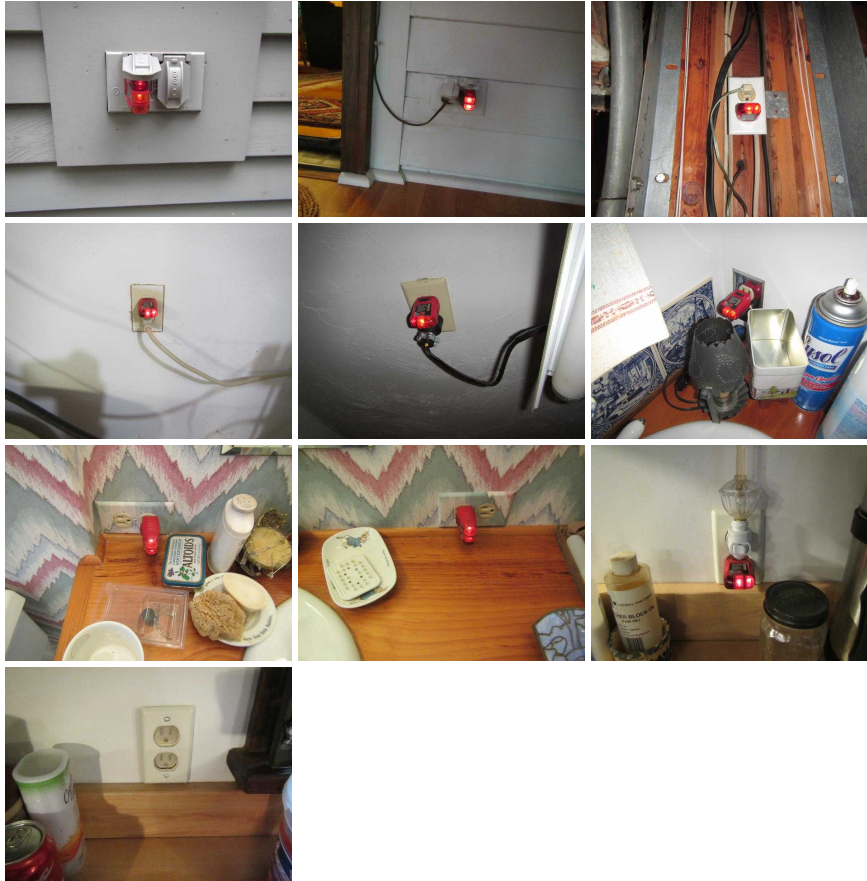
18. GFCI: Not present - Non GFCI protected outlets at exterior front and rear porch. Non GFCI protected outlets at basement shop area. Non GFCI protected outlets at interior of garage. Non GFCI protected outlets at first floor and master bathrooms. Non GFCI protected outlets at kitchen countertops. Non GFCI protected outlets in first floor bathroom at sink and behind washing machine. Evaluation and estimate of repair by a licensed electrician is recommended.

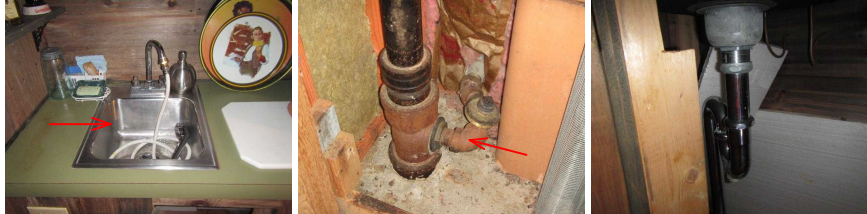
10. Sink: Basement bar sink - Improperly terminated into main drain pipe through cleanout trap. Improper type "S" trap under sink. A licensed plumber is recommended to evaluate and estimate repairs.

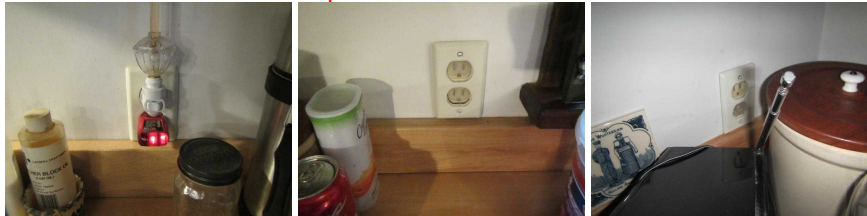
11. Electrical: 120 VAC outlets and lighting circuits - Non-GFCI protected outlet circuits. Recommend GFCI protected circuit be installed. A licensed electrician is recommended to evaluate and estimate repairs.

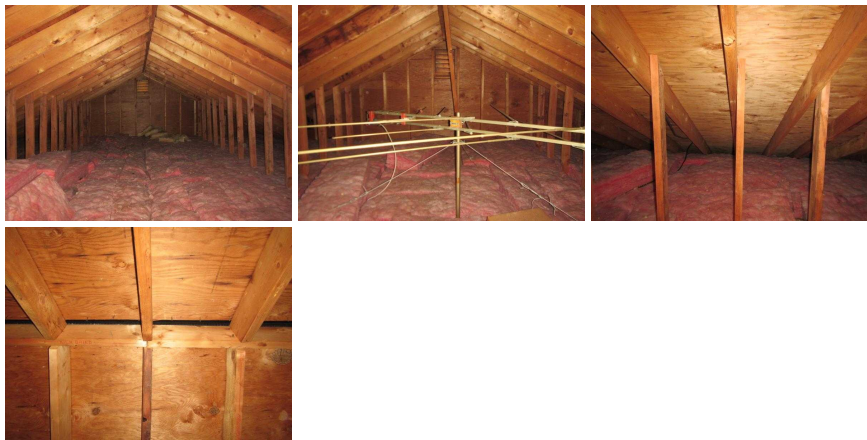
13. Moisture Penetration: No moisture present at the time of inspection
14. Bathroom Fan Venting: Roof vented
15. Additional comments Attic space - Attic viewed from pull down stairs. Attic viewed from wood flooring. Attic viewed with high power LED flash-lite. Attic viewed with daylight through vents.

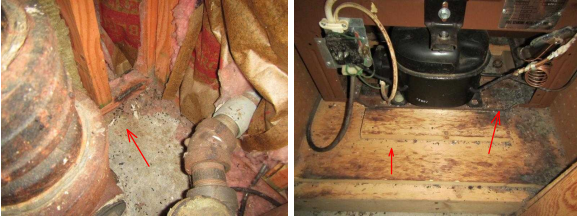
9. Main basement under the dwelling Basement Additional comments Basement area - Evidence of past and/or present rodent activity (mice) at the time of inspection, recommend further review by a licensed pest control company for seasonal treatment as needed.

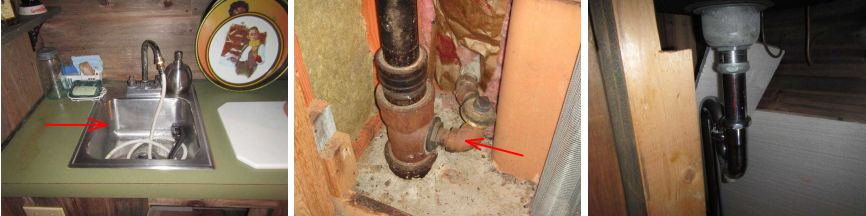
15. First floor Kitchen Sink: Basement bar sink - **Improperly terminated into main drain pipe through cleanout trap. Improper type "S" trap under sink. A licensed plumber is recommended to evaluate and estimate repairs.**

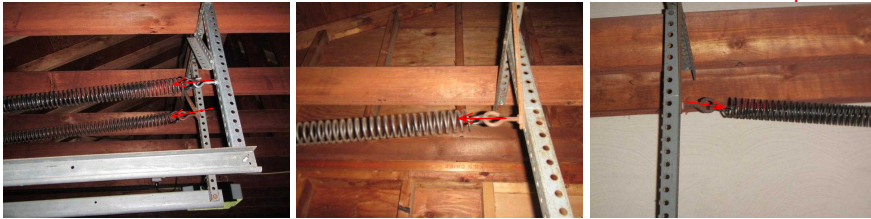
6. Left side Garage Garage Doors: Hardboard - **Missing safety cables at overhead door springs. A qualified contractor is recommended for evaluation and estimate of repair.**

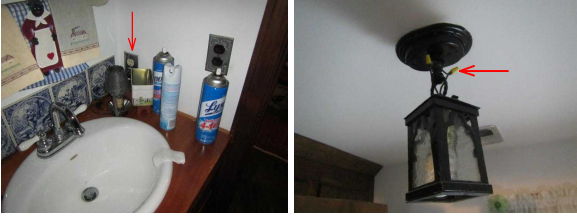
13. First floor Bathroom Electrical: 120 VAC outlets and lighting circuits - **Non-GFCI protected outlet circuit. Recommend GFCI protected circuit be installed. Improperly wired ceiling light fixture. Wire splice is not contained inside of a junction box. A licensed electrician is recommended to evaluate and estimate repairs.**

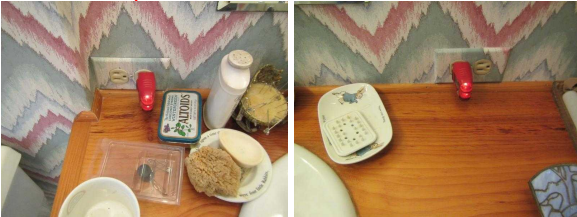
14. Master bedroom Bathroom Electrical: 120 VAC outlets and lighting circuits - **Non-GFCI protected outlet circuits. Recommend GFCI protected circuits be installed. A licensed electrician is recommended to evaluate and estimate repairs.**

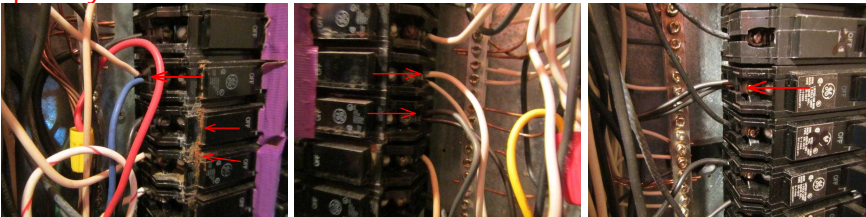
17. Smoke & Carbon Monoxide Detectors Battery operated smokes, no carbon monoxide detectors - **Not tested, Fire Marshall to inspect, Certificate of compliance required from home owners at closing.**
18. Basement Electric Panel Branch Circuits: 44 branch circuits - **Double tapped service breakers are present inside of the main electrical service panel. Corrosion is present on service breakers. Evaluation and estimate of repair by a licensed electrician is recommended.**

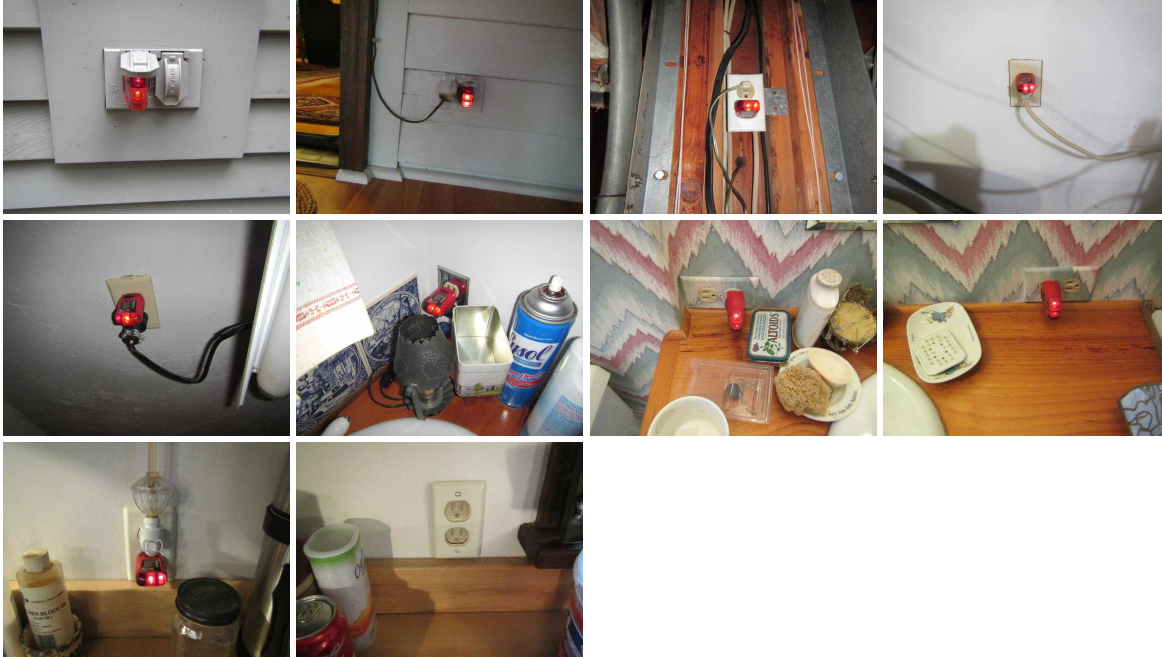
GFCI: (continued)

19. Basement Electric Panel GFCI: Not present - **Non GFCI protected outlets at exterior front and rear porch. Non GFCI protected outlets at basement shop area. Non GFCI protected outlets at interior of garage. Non GFCI protected outlets at first floor and master bathrooms. Non GFCI protected outlets at kitchen countertops. Non GFCI protected outlets in first floor bathroom at sink and behind washing machine. Evaluation and estimate of repair by a licensed electrician is recommended.**

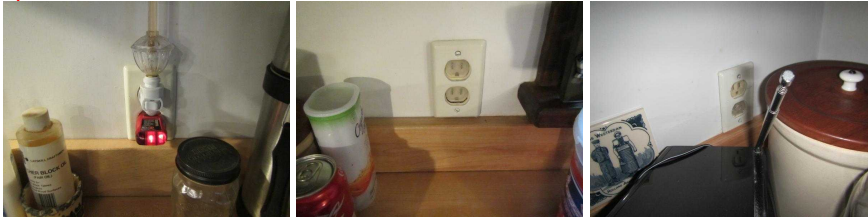
27. First floor Kitchen Electrical: 120 VAC outlets and lighting circuits - **Non-GFCI protected outlet circuits. Recommend GFCI protected circuit be installed. A licensed electrician is recommended to evaluate and estimate repairs.**
