American Home Inspections, Inc.

Inspection #: 07178382 Inspector: Rick Contonio
Date: 7/6/2017
Property Address: 30 Chiltern Hill Drive
Worcester, MA
Client Name: Ethan Crumlin

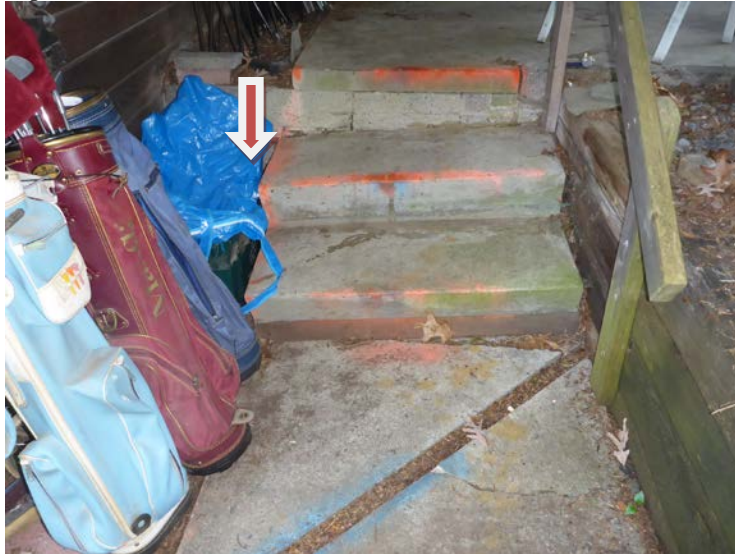
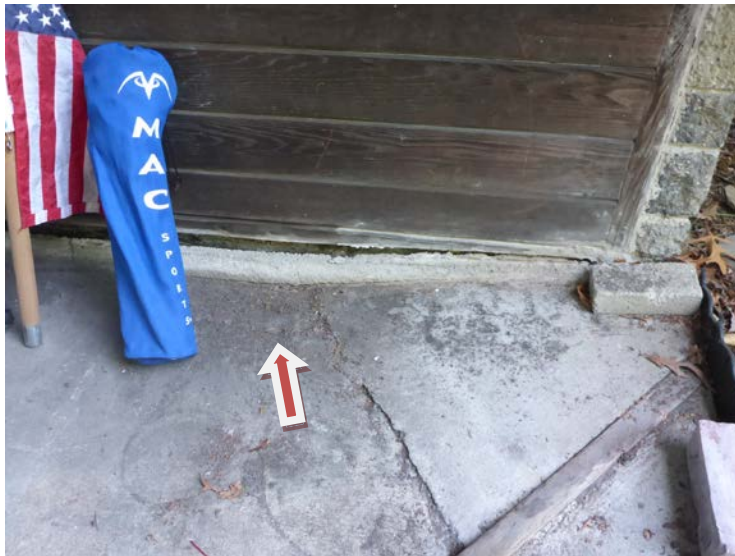
102. Walkways
(Including stairs,
stoops)

Asphalt and concrete. Cracked/settled/deteriorated.

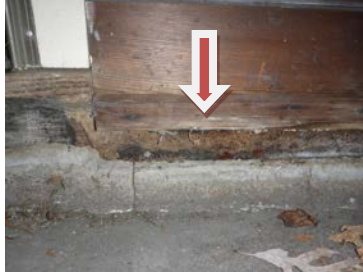
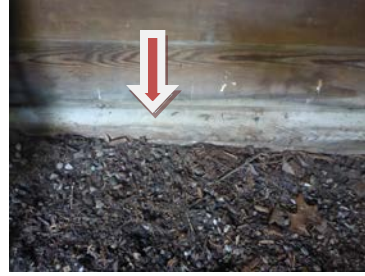
104. Siding (Wall cladding)

Horizontal board and what appears to be stucco with concrete product at front. Deterioration evident at base of siding around front entry door. Wood to earth contact noted.

This area is susceptible to deterioration and possible wood destroying insect infestation. Concealed issues may exist. We suggest removing earth from base of wood and repair of any deterioration as needed by a licensed contractor. Boards weathered/deteriorated at right side.

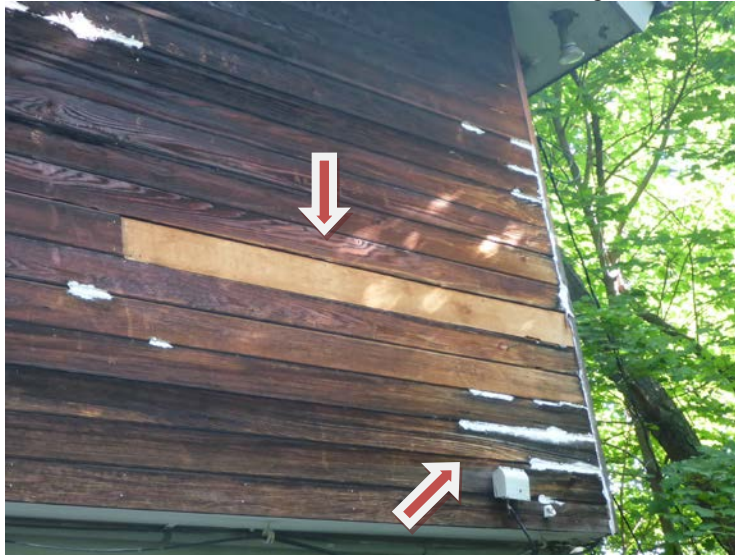
Areas patched. Unable to determine if, or to what degree, water has penetrated behind this siding. Concealed issues may exist. Suggest confirming/repair as needed.

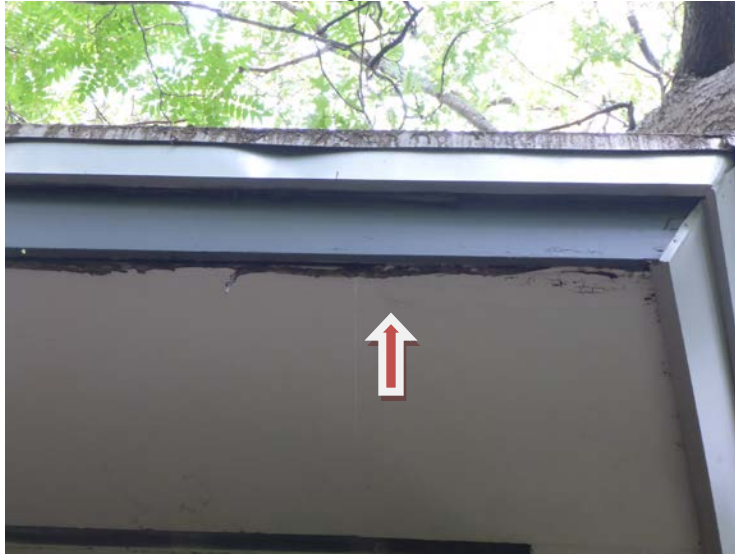
105. Trim (Including eaves, soffits, fascias and corner boards)

Wood. Deterioration noted at edges of soffit/roof.

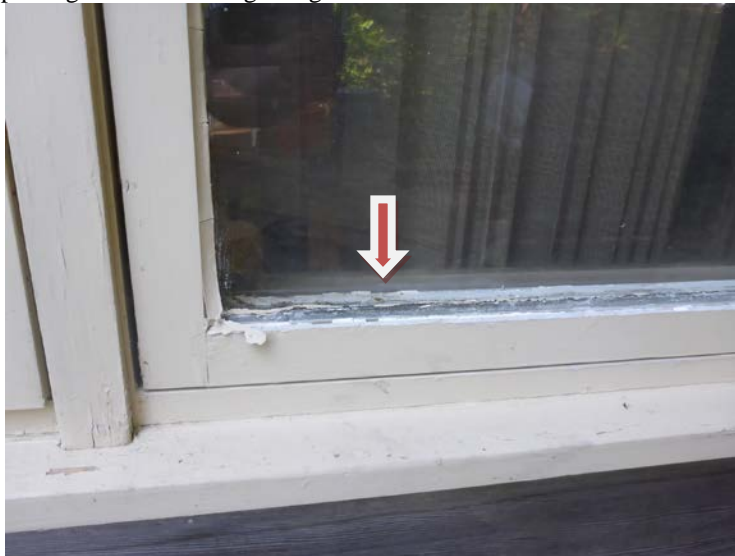
106. Windows
(Including exterior frames and trim)

Unable to determine extent without destructive investigation. Concealed issues may exist. Suggest confirming/repair as needed.
Wood frame, single and double pane, awning and fixed pane. Paint peeling on frames. Re-glazing needed. Frames weathered.

Single pane windows present without storms installed. Suggest installing storm windows or updating these windows for energy saving purposes and to improve the comfort of occupants.

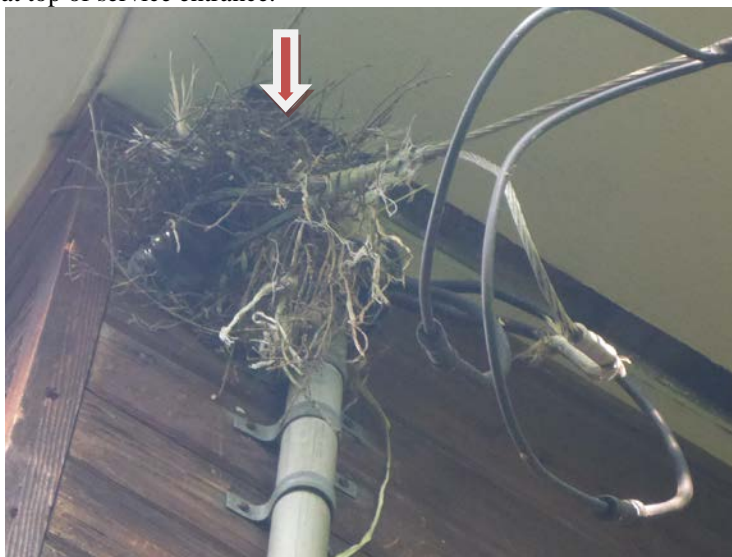
107. Electrical Main electric service entrance is overhead. Bird/animal activity evident at top of service entrance.

Suggest removing. Lights at left side of driveway damaged.

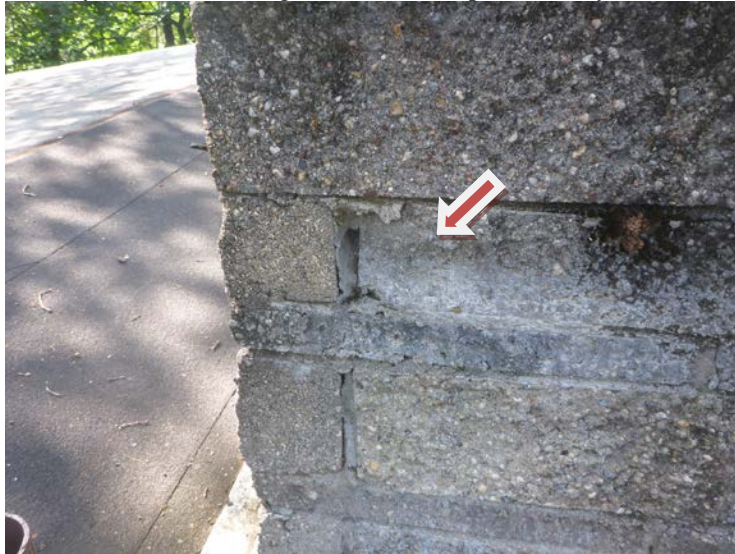
112. Chimney

Masonry. One flue. Damage evident near top of chimney.

Suggest repair as needed. The chimney review is limited to the visible/accessible components only. Examination of concealed/inaccessible portions of the chimney is beyond the scope of this inspection. This includes determining the presence of flue linings, or if linings are present, checking for deterioration, damage or cracks. If concerned about the interior condition of these flues, we suggest you obtain the opinion of a qualified chimney sweep prior to closing.

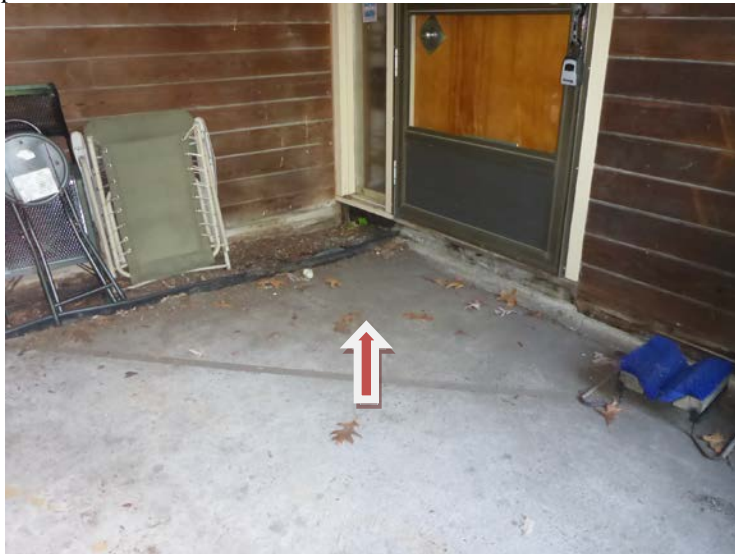
113. Lot/Grade Drainage

Home is built on a sloped lot. Grade at foundation appears inadequate. Area around front entry door susceptible to water accumulation, penetration and deterioration.

Suggest adjusting/repair as needed to manage water away from the structure.

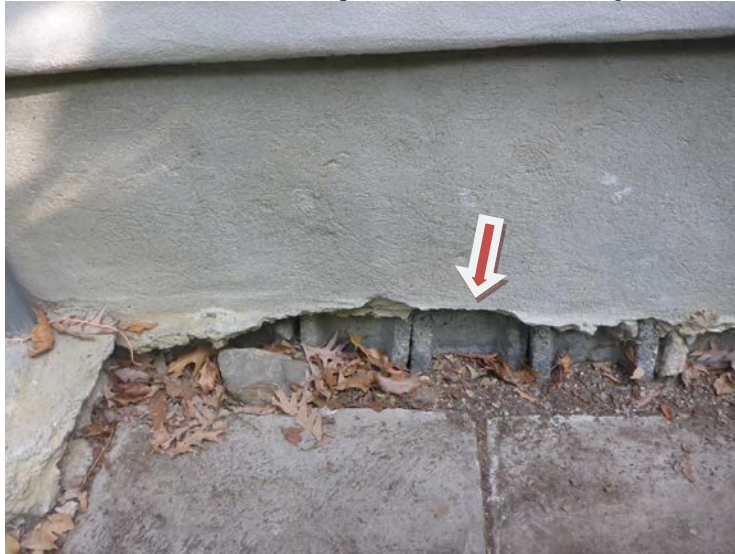
115. Exposed
Foundation

Concrete. Poured and block. Exposed blocks evident at right rear.

Walk may have been removed from this area. Suggest confirming history with homeowner.

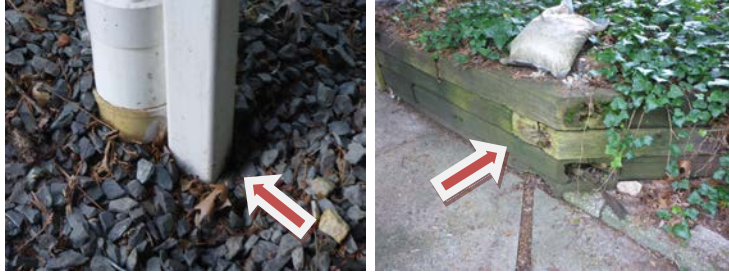
Unable to access base of metal support outside front entry area to confirm condition. Located below grade. Wood retaining wall at right side deteriorated.

Suggest repair/replacing as needed. Trees hitting siding, trim and/or roof areas.

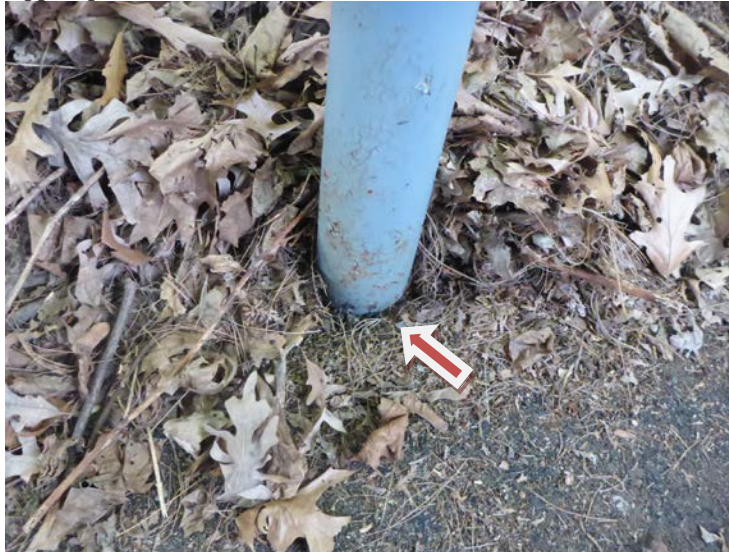
Suggest removing vegetation to prevent moisture accumulation and damage. Carport sways/moves when pushed on. Client may wish to brace this carport to prevent movement. Unable to access base of metal support posts to confirm condition. Posts below grade.

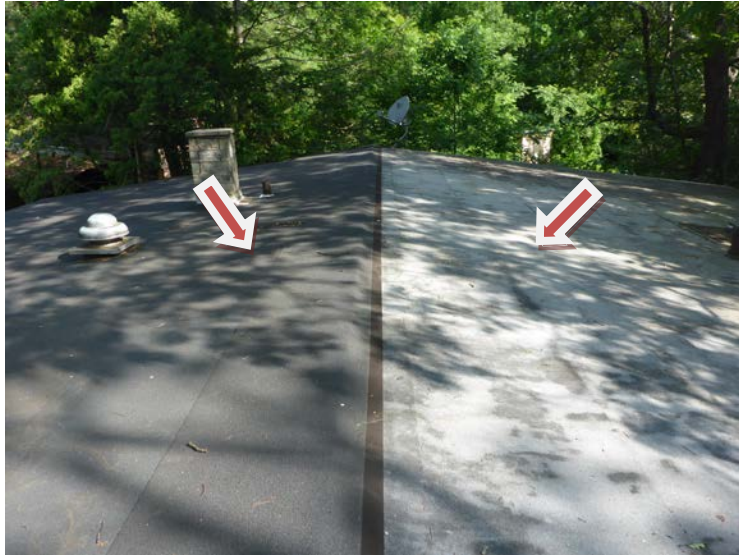
306. Conditions

Rear portion of roof appears older than front.

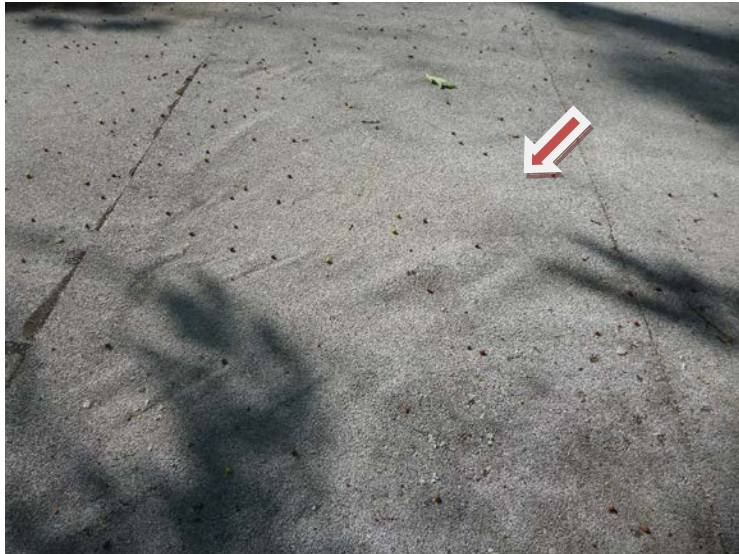
Granule loss evident. Areas lifted/blistered.

Moisture may be present below these areas. Suggest confirming/repair as needed. Remainder of roof covering shows normal wear for its age and type; appears to be in serviceable condition.

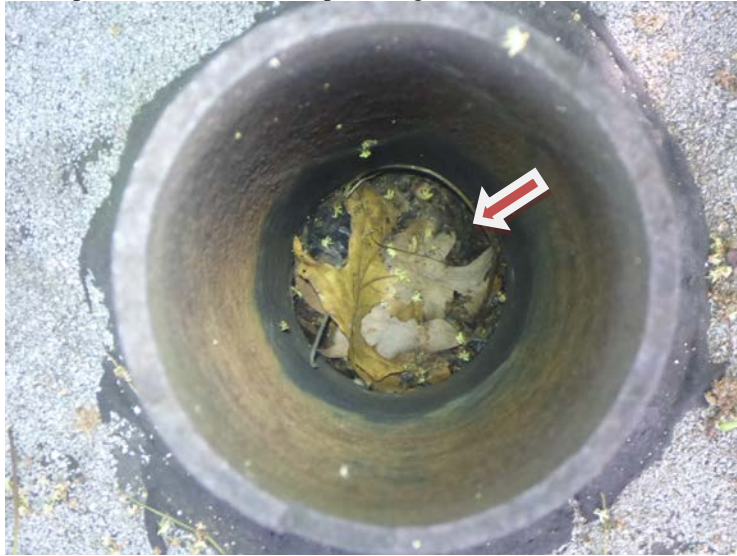
308. Roof Penetrations Buildup/debris evident in one plumbing vent.

Suggest cleaning.

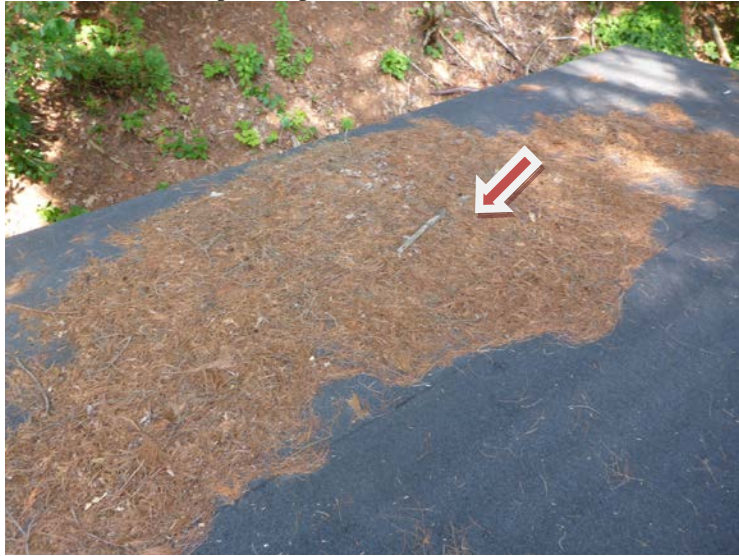
Debris evident on top of carport roof.

Limited view. Suggest removing and confirming condition. Damaged drip edge/trim noted at rear.

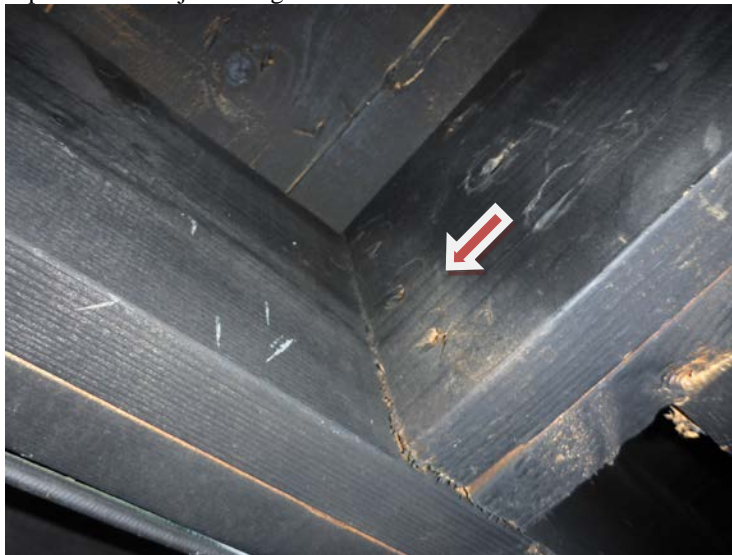
Step #	Component	Comment
421.	Exterior Access	Door at right side.
422.	Stairs	S
423.	Railings	None present at lower portion of stairs. Suggest installing.
424.	Floor	Concrete and finished.
425.	Walls/Ceilings	Walls are concrete. Ceiling is open framing.
426.	Exposed Foundation	Concrete. Unable to view large portion of foundation due to excessive amount of stored items.
427.	Floor Joists	2x10, approximately 16 inch on center. Portions of framing toe-nailed in place without joist hangers.

Suggest installing joist hangers where needed.
428.	Support Posts/Columns	Metal. Unable to view where boxed in, where walls are finished or where blocked by stored items.
429.	Beams	Metal I beam. Unable to view where walls/ceilings are finished.
430.	Sills	Unable to access sill area due to size constraints and excessive amount of stored items.
431.	Windows	Unable to view/access due to excessive amount of stored items.

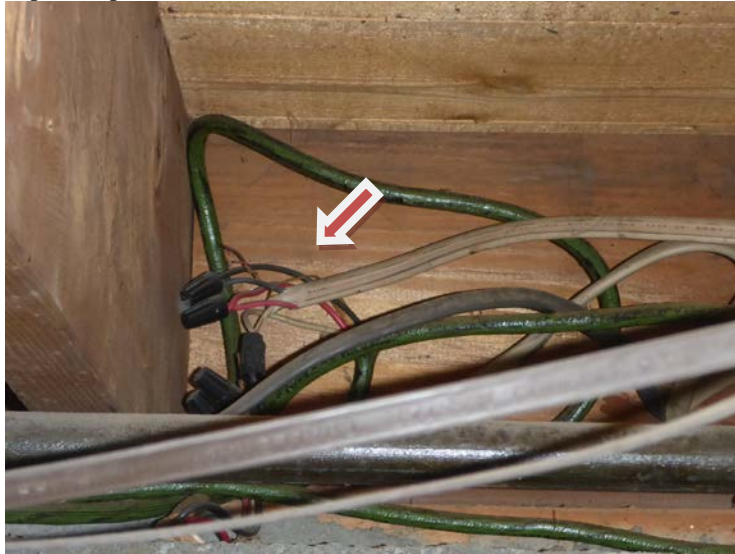
432. Electrical

Exposed splices noted.

Light(s) appear permanently wired with lamp cord. Suggest repair as needed.

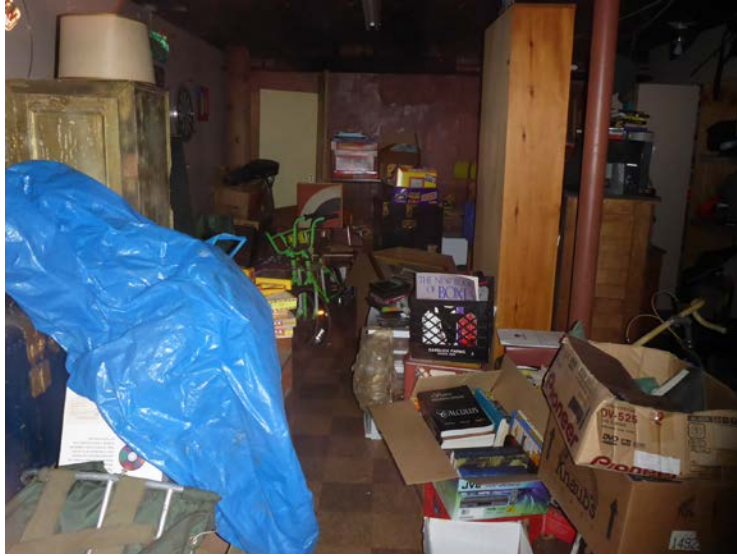
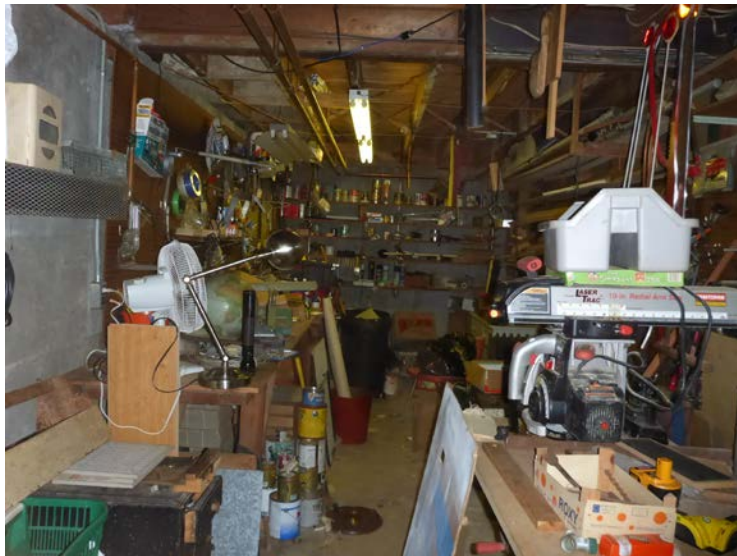
Limited view/access to basement areas due to excessive amount of stored items.

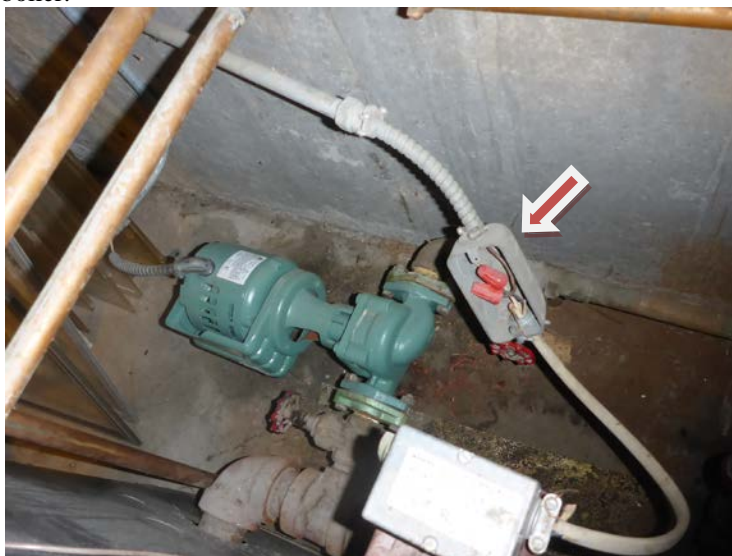
904. Heating Conditions No back flow preventer installed in water supply line to boiler. This device may not have been required when system was installed, however, client may wish to install for safety. Loose/exposed wiring evident at boiler.

Suggest repair as needed. Boiler appears original and likely very close to the end of its useful life. Client should anticipate replacement. Area housing heating system may not be large enough to adequately supply combustion air. Suggest confirming/repair/adjusting as needed by a qualified heating contractor.

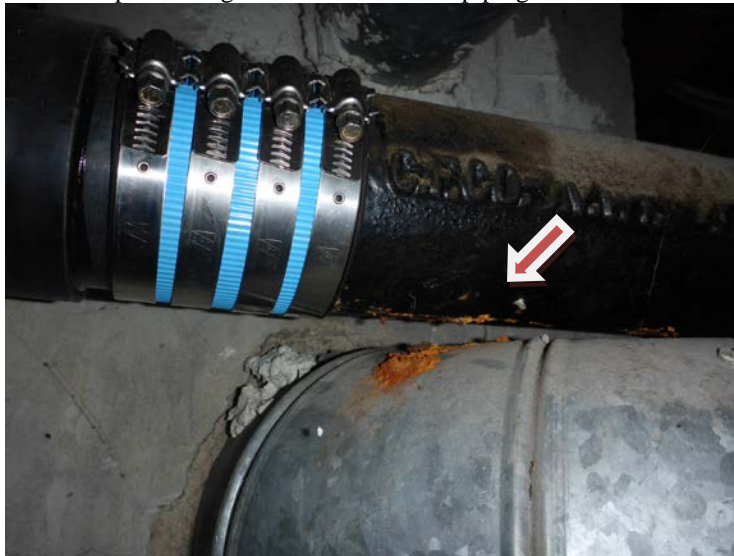
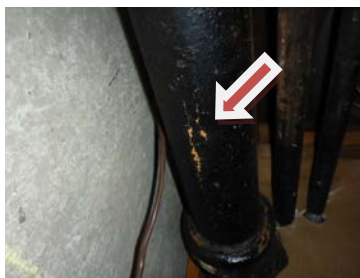
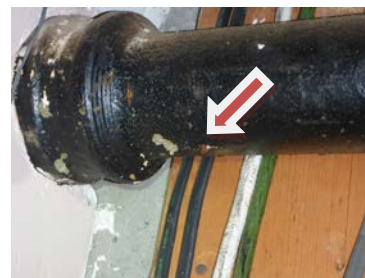
Step #	Component	Comment
1001.	Supply System	Water supply provided by public system. Main shut off located adjacent to water meter at basement right side. Supply piping, where visible, is copper with a copper main.
1002.	Supply Comments	Unable to view supply piping walls/ceilings are finished.
1003.	Waste System	Property was reported to be connected to the public sewer system. Client may wish to confirm sewer connection with the local building department or the property owner prior to closing. Waste piping, where visible, is cast iron and plastic.
1004.	Waste Comments	Corrosion/past leakage evident at cast iron piping in basement.

Suggest review/repair as needed by a licensed plumber. Unable to view/access portions of this drain piping due to excessive amount of stored items.

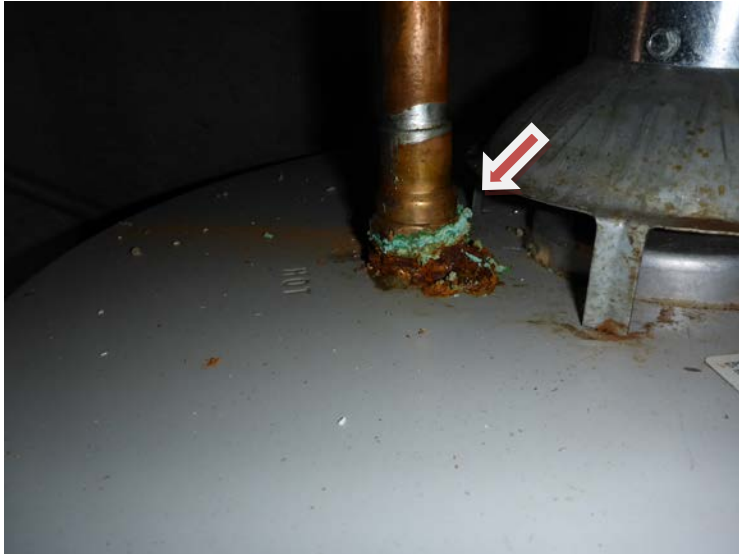
Step #	Component	Comment
1051.	Water Heater	<p>Forty gallon, gas. Located at basement left side. Cold water shut off is intact. Temperature/pressure relief valve installed for safety. Vacuum relief valve present. Corrosion noted.</p>

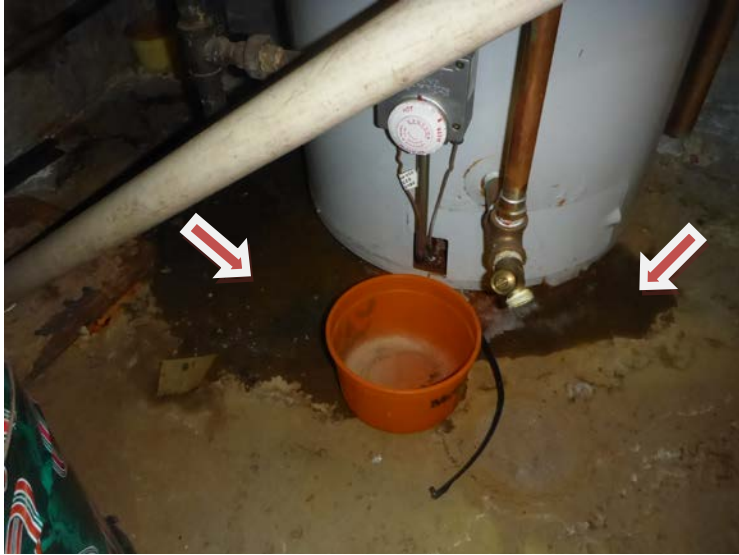
<p>Heater leaking.</p>

1052.	Venting	<p>Heater appears to be approximately fifteen years old. Suggest replacing. Appears intact.</p>

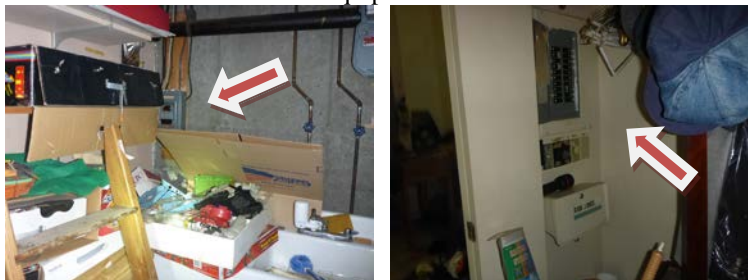
Unable to access sub panel at basement left rear and in front entry closet due to stored items/hazardous equipment/locations.

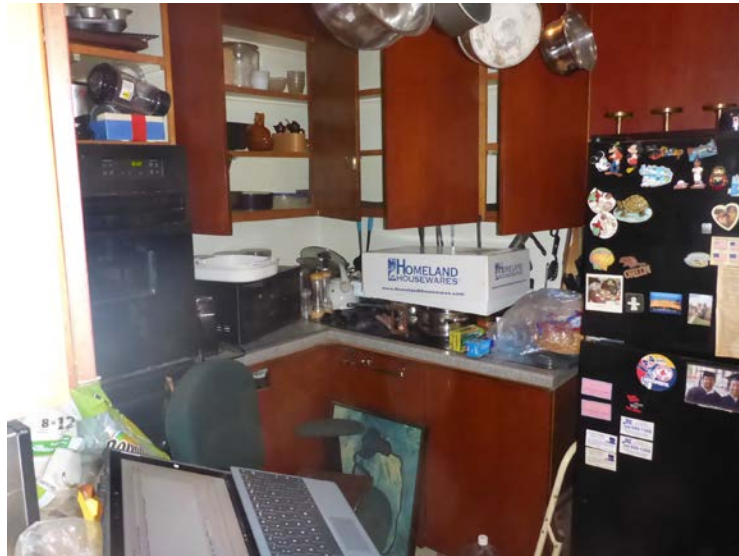
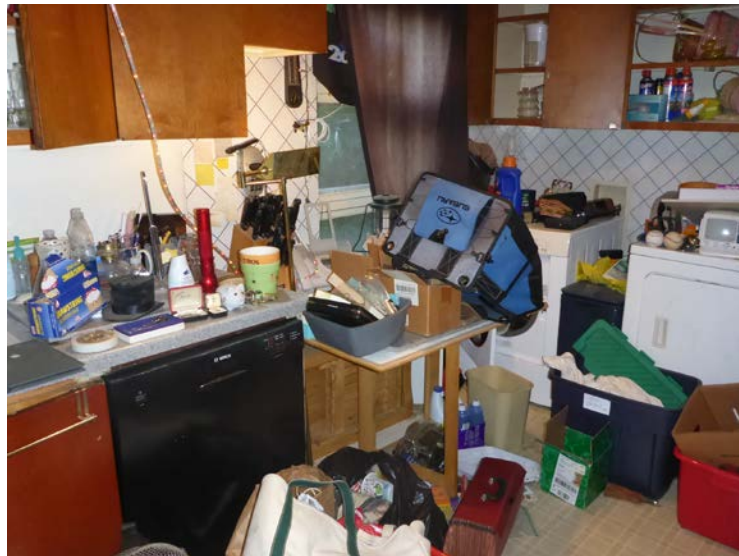
Limited view due to stored items.

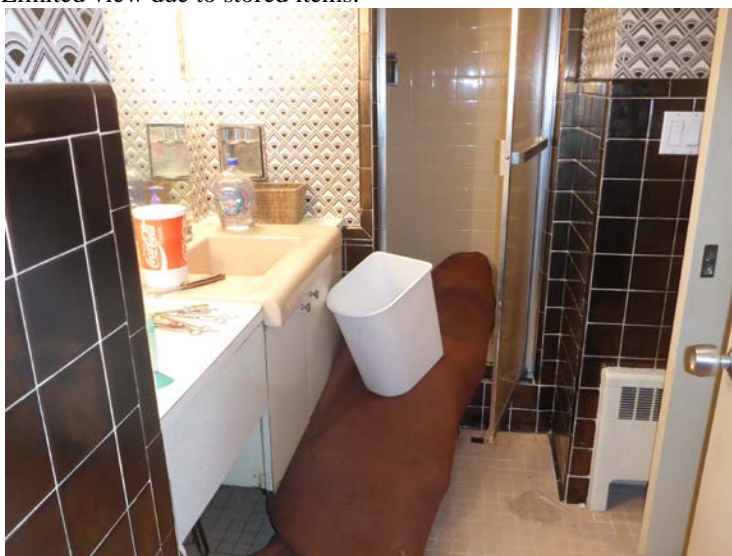
Step #	Component	Comment
1401.	Location	Upper level hall.
1402.	Floor	Tile.
1403.	Walls	Plaster and/or gypsum board.
1404.	Ceiling	Plaster and/or gypsum board.
1405.	Doors	S
1406.	Windows	N
1407.	Electrical	Wall outlet is ground fault protected.
1408.	Exhaust Fan	Fan/light unit installed inside shower. Unable to determine if rated for this location. Unit does not appear ground fault protected. Suggest confirming/installing approved fan/light as needed.
1409.	Heat/Cooling Source	Convector unit present.
1410.	Tub/Surround	N
1411.	Tub Enclosure	N
1412.	Tub Faucet	N
1413.	Shower	Excessive caulking noted.
1414.	Shower Door	Not operated due to stored items.
1415.	Shower Faucet	Not operated due to stored items.
1416.	Sink	S
1417.	Sink Faucet	S
1418.	Traps/Drain Supply	Improper trap noted below sink. Suggest repair as needed.
1419.	Toilet	S
1420.	Counter	S
1421.	Comments	Limited view due to stored items.

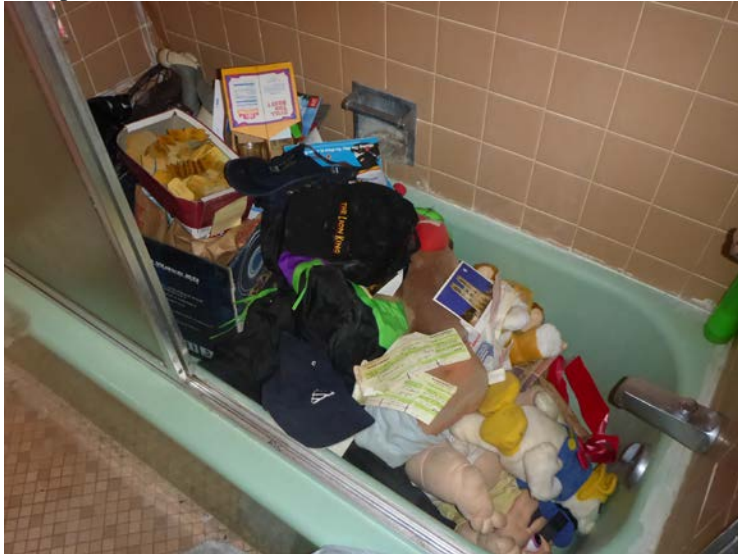
Step #	Component	Comment
1431.	Location	Mid level hall.
1432.	Floor	Tile.
1433.	Walls	Plaster and/or gypsum board.
1434.	Ceiling	Plaster and/or gypsum board.
1435.	Doors	S
1436.	Windows	Awning.
1437.	Electrical	Wall outlet is ground fault protected.
1438.	Exhaust Fan	N
1439.	Heat/Cooling Source	Baseboard heat source observed.
1440.	Tub/Surround	Tile uneven. Areas caulked excessively. Concealed damage may exist.
1441.	Tub Enclosure	S
1442.	Tub Faucet	Not operated due to stored items in tub.

1443.	Shower	See #1440.
1444.	Shower Door	S
1445.	Shower Faucet	Not operated due to stored items in tub.
1446.	Sink	S
1447.	Sink Faucet	Damage noted.
1448.	Traps/Drain Supply	S
1449.	Toilet	S
1450.	Counter	S
1451.	Comments	None.

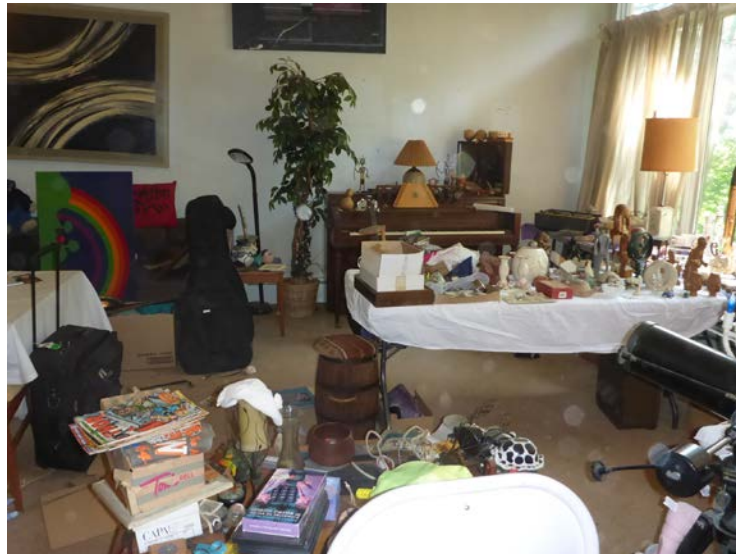
Step #	Component	Comment
1601.	Floor	Carpeted.
1602.	Walls	Plaster and/or gypsum board.
1603.	Ceiling	Acoustic tile.
1604.	Doors	N
1605.	Windows	Awning and fixed pane. Unable to access due to stored items.
1606.	Electrical	S
1607.	Fireplace	N
1608.	Heat/Cooling Source	Baseboard heat source observed.
1610.	Comments	Limited view due to stored items.

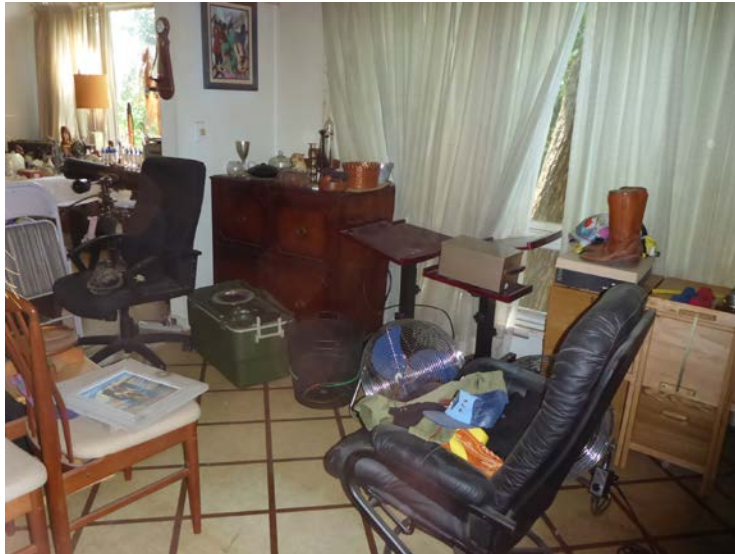
Step #	Component	Comment
1701.	Floor	Resilient.
1702.	Walls	Plaster and/or gypsum board.
1703.	Ceiling	Acoustic tile.
1704.	Doors	N
1705.	Windows	Awning and fixed pane. Unable to access due to stored items.
1706.	Electrical	S
1707.	Fireplace	N
1708.	Heat/Cooling Source	Baseboard heat source observed.
1710.	Comments	Limited view due to stored items.

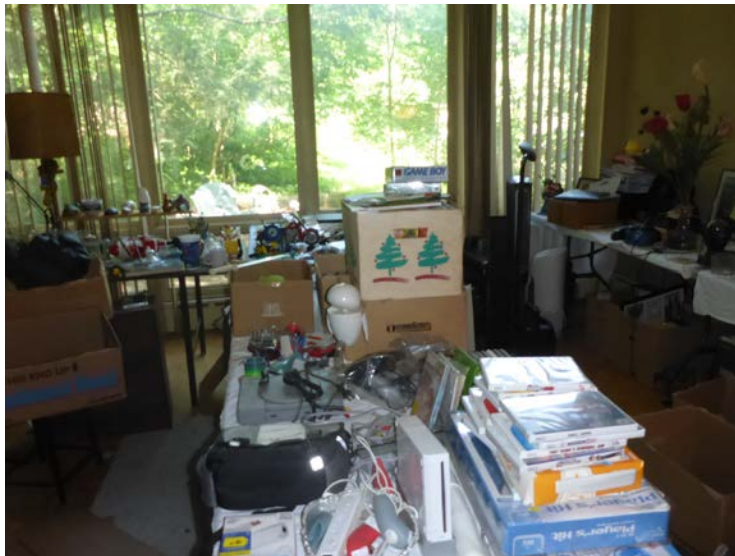
Step #	Component	Comment
1801.	Location	First floor left side.
1802.	Floor	Wood.
1803.	Walls	Plaster and/or gypsum board.
1804.	Ceiling	Plaster and/or gypsum board.
1805.	Doors	N
1806.	Windows	Awning and fixed pane. Limited view due to stored items.
1807.	Electrical	S
1808.	Fireplace	N
1809.	Heat/Cooling Source	Baseboard heat source observed.
1810.	Comments	Limited view due to stored items.

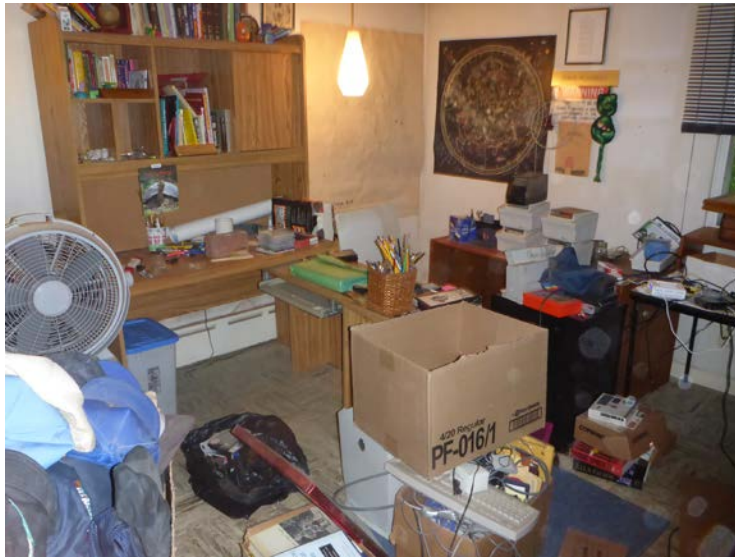
Step #	Component	Comment
3301.	Location	Upper level left rear.
3302.	Floor	Resilient.
3303.	Walls	Plaster and/or gypsum board.
3304.	Ceiling	Plaster and/or gypsum board.
3305.	Doors	S
3306.	Windows	Awning.
3307.	Electrical	S
3308.	Fireplace	N
3309.	Heat/Cooling Source	Baseboard heat source observed.
3310.	Closet	S
3311.	Comments	Limited view due to stored items.

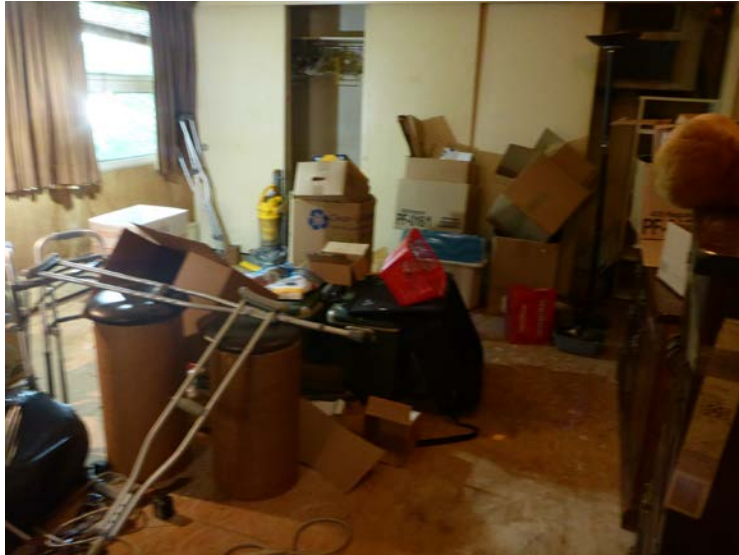
Step #	Component	Comment
3401.	Location	Upper level right rear.
3402.	Floor	Wood.
3403.	Walls	Plaster and/or gypsum board.
3404.	Ceiling	Plaster and/or gypsum board.
3405.	Doors	S
3406.	Windows	Awning.
3407.	Electrical	S
3408.	Fireplace	N
3409.	Heat/Cooling Source	Baseboard heat source observed.
3410.	Closet	S
3411.	Comments	Limited view due to stored items.
