Inspection #: 06198668      Inspector: Rick Contonio

Date: 6/10/2019

Property Address: 5 Pleasant Street  
Shrewsbury, MA 01545

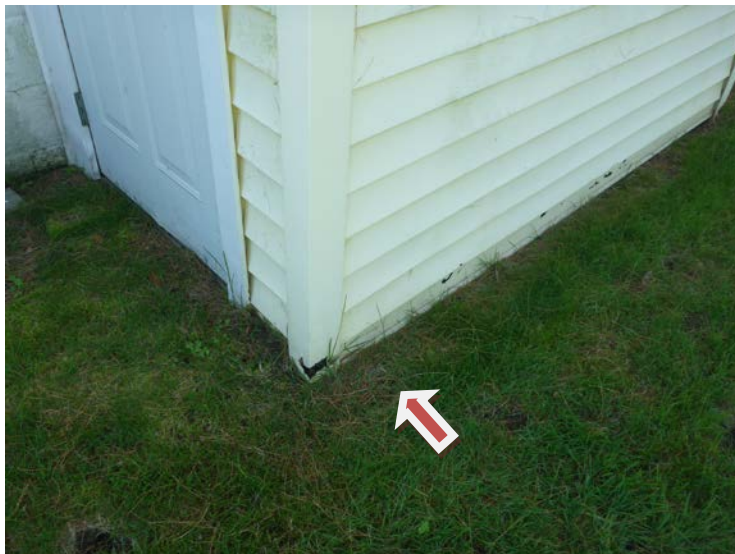
Step #	Component	Comment
101.	Driveway	Asphalt.
102.	Walkways (Including stairs, stoops)	Asphalt. Exterior steps are concrete.
103.	Fences/Gates	Wood and chain link.
104.	Siding (Wall cladding)	Vinyl with brick at front. Vinyl in contact with grade at rear. Damage evident.

Unable to determine if deterioration has occurred behind vinyl. Suggest confirming, removing earth from base of siding and managing water away from this area to prevent water penetration and deterioration.

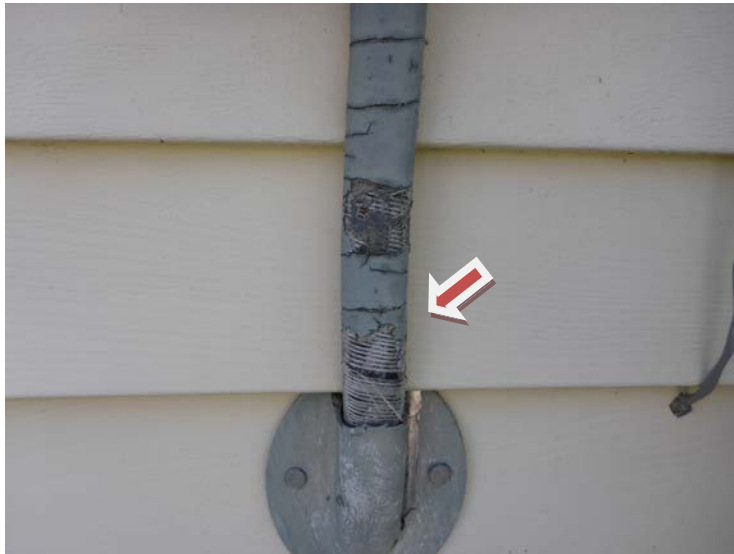
| 107. | Electrical | Main electric service entrance is overhead. Insulation deteriorated on main electric service feed wire. |

Meter box loose. Suggest repair/replacing as needed by a licensed electrician. Exterior outlets are not ground fault circuit interrupter (GFCI) protected. Suggest installing approved ground fault protection for safety. We check a representative number of exterior lights. If concerned, we suggest confirming operation of all exterior electrical fixtures.

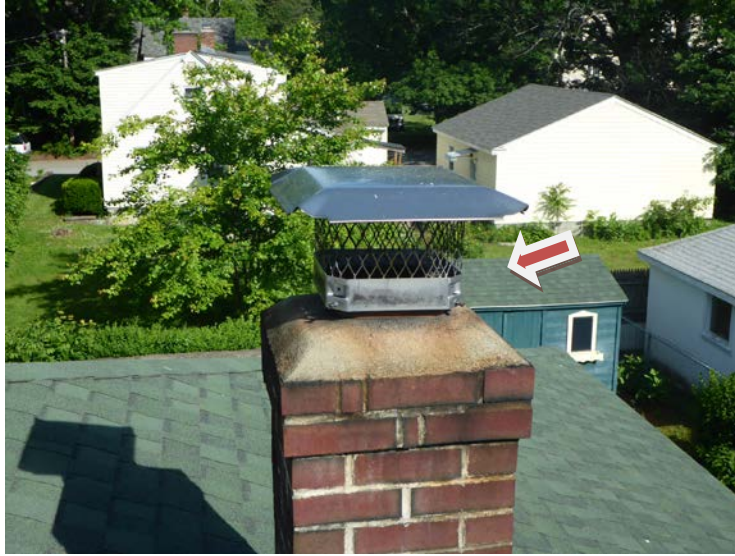
112. Chimney

Masonry. One flue. Chimney exterior appears in serviceable condition. Unable to view inside chimney from roof due to rain cap.

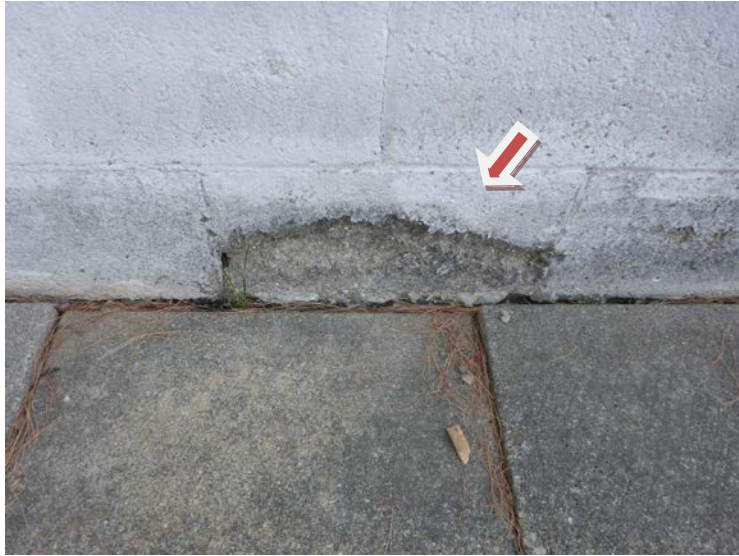
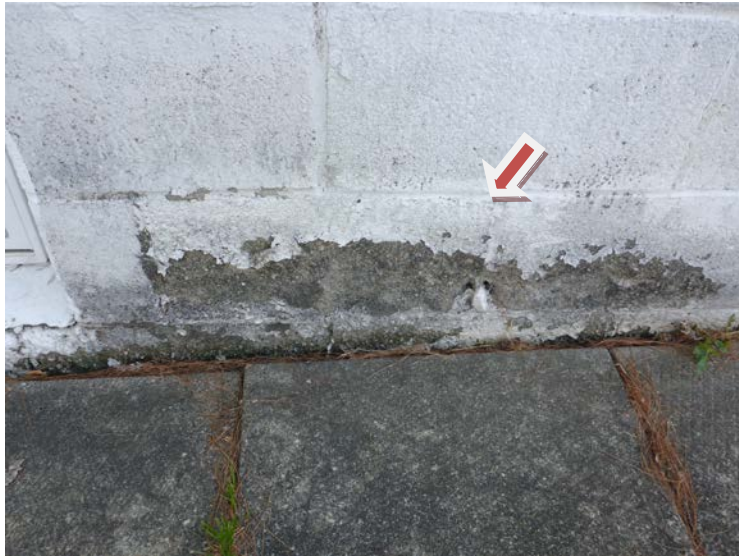
115. Exposed  
Foundation

Concrete block. Surface deterioration evident in areas.

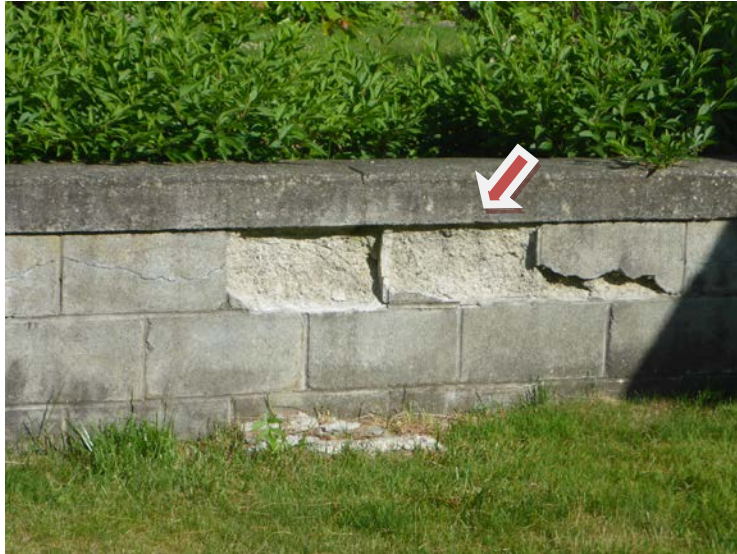
117.      Comments

Deterioration evident at rear concrete block wall.

Suggest repair as needed. Storage shed present and is not within the scope of our inspection.

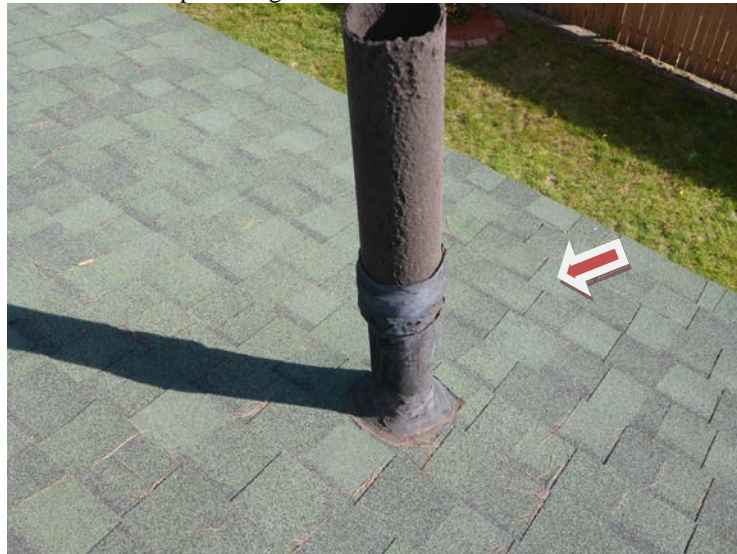
Step #	Component	Comment
301.	Roof Type	Hip.
302.	Covering	Asphalt composition shingle.
303.	How Observed	From on top of the roof.
304.	Number of Layers	Appears to be two.
305.	Flashing	Where visible, appears intact.
306.	Conditions	Roof covering shows normal wear for its age and type; appears to be in serviceable condition.
307.	Skylights	N
308.	Roof Penetrations	Sealant noted at plumbing vent stack.

Leakage possible sometime in the past. Unable to determine if active. Suggest monitoring/repair as needed.

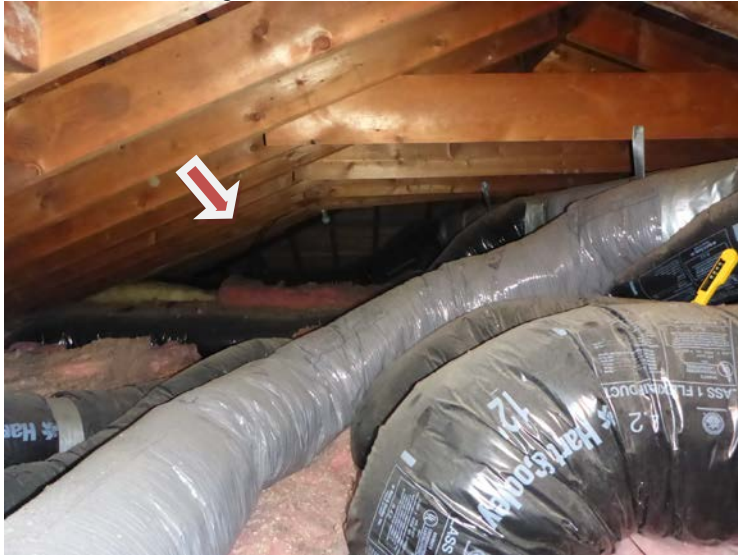
Step #	Component	Comment
401.	Access	Pull down stairs located at rear hall. Access to attic area was extremely limited due to ducting, insulation, air handler and size constraints.

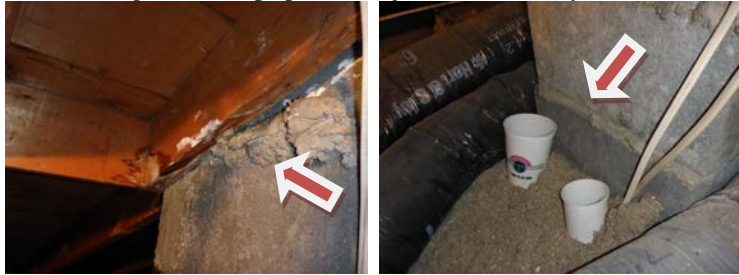
405. Evidence of Leakage

Yes. Staining noted. Cups present adjacent to chimney.

Unable to determine if active. Possibly from previous roof. Suggest confirming/repair as needed.

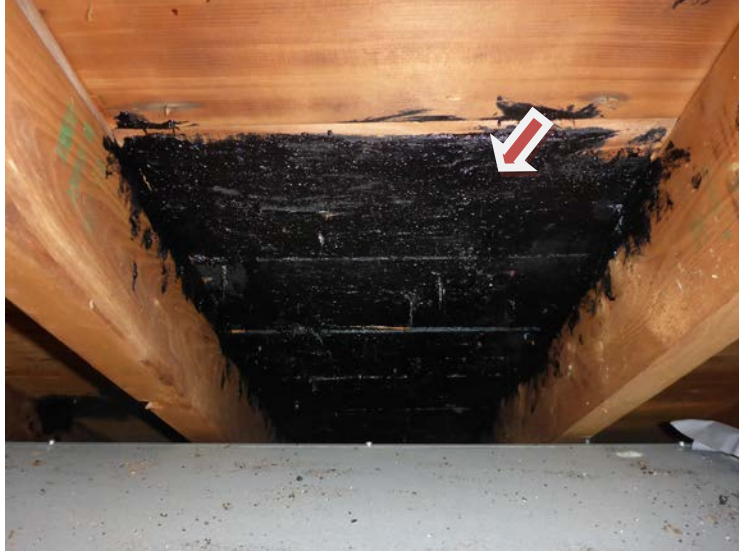
Underside of roof sheathing sealed with what appears to be roof cement.

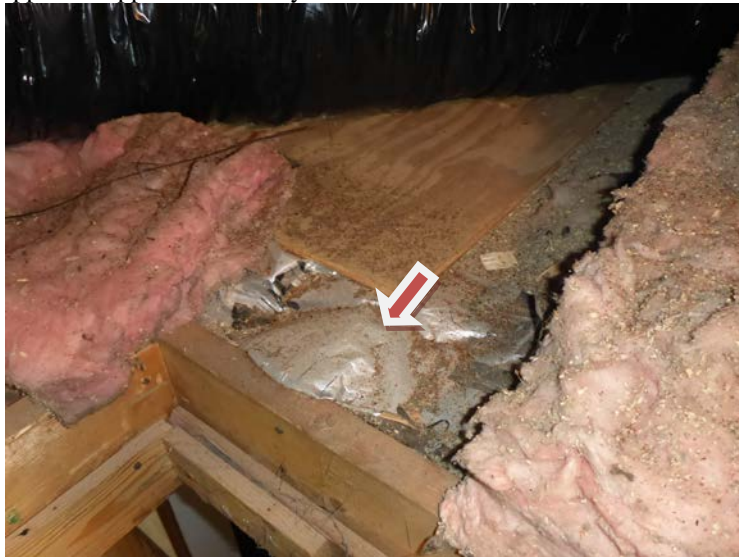
406. Insulation

Loose cellulose and fiberglass batts. Where visible, approximate thickness is four to ten inches depending on location. Vapor barrier appears trapped between layers of insulation.

Suggest removing all vapor barrier material other than layer against heated space below and insulating over pull down stairs.

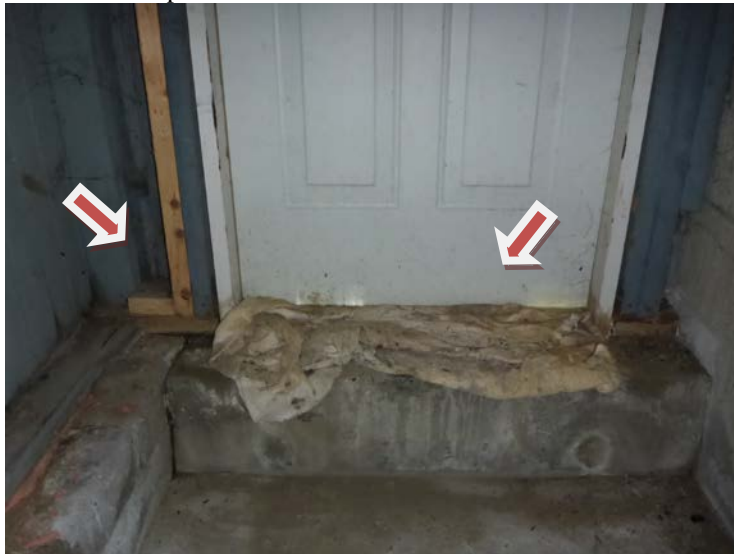
Step #	Component	Comment
421.	Exterior Access	Door at rear. Deteriorated wood evident. Repair noted adjacent to base of door. Towel present at base of door.

Water penetration evident sometime in the past. Floor drain present in this area. Unable to determine effectiveness or where drain terminates. Suggest repair as needed.
422.	Stairs	Located off living room.
423.	Railings	S
424.	Floor	Concrete and finished.
425.	Walls/Ceilings	Walls are concrete block. Ceiling is open framing. (See also finished room comments.)

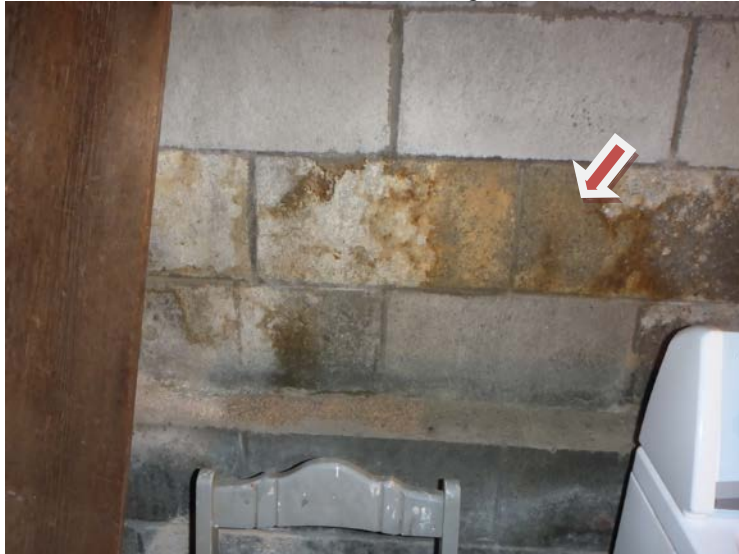
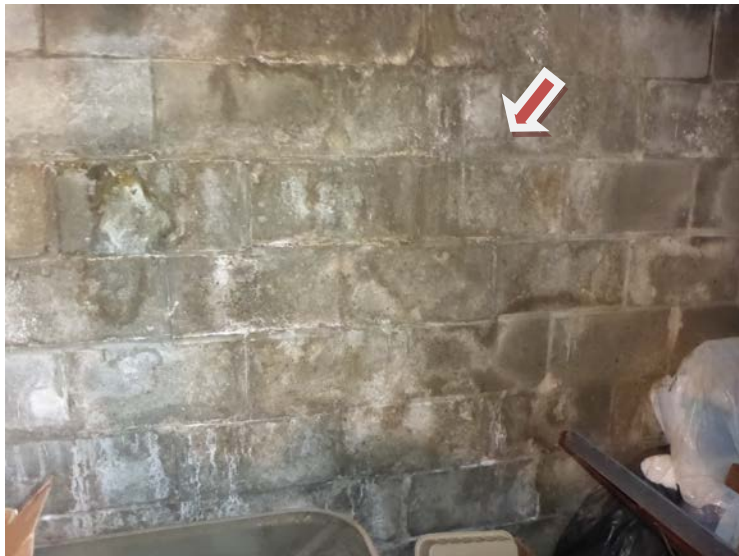
426. Exposed  
Foundation

Concrete block. Efflorescence/water staining noted.

This indicates moisture and/or water penetration sometime in the past. Unable to view foundation where walls are finished or blocked by stored items.

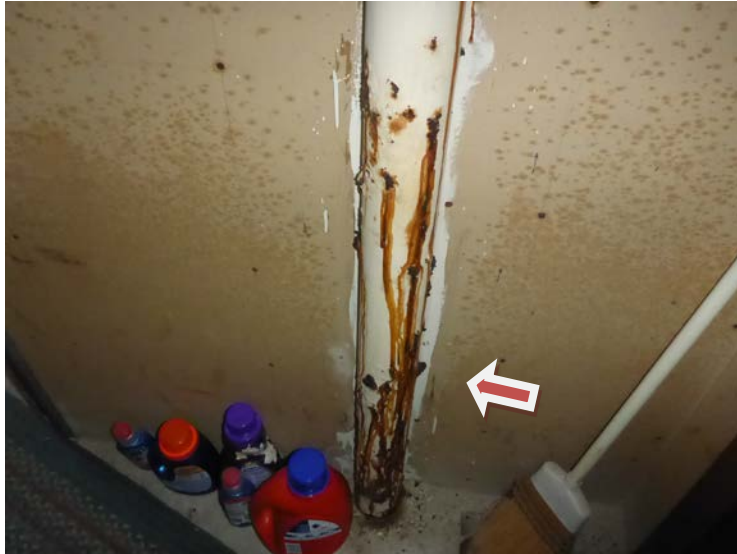
428. Support  
Posts/Columns

Metal. Corrosion evident.

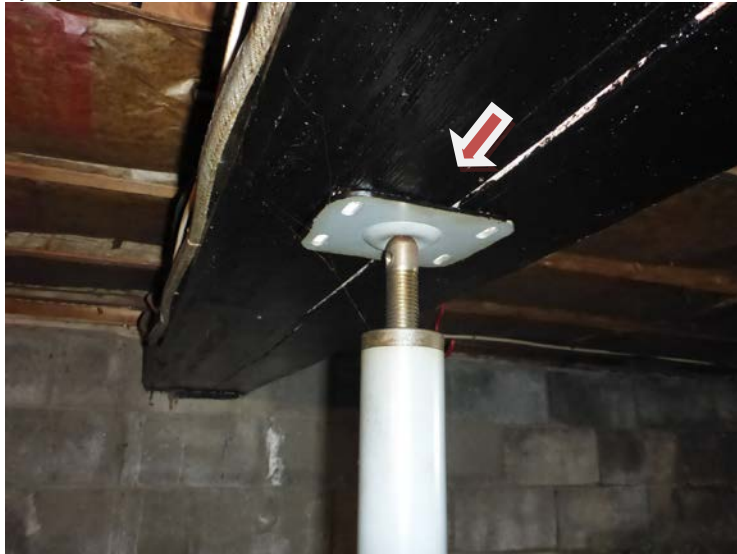
Portions of these columns appear to have been replaced with temporary style jack columns.

Suggest installing approved, permanent type columns with proper footings below this beam.

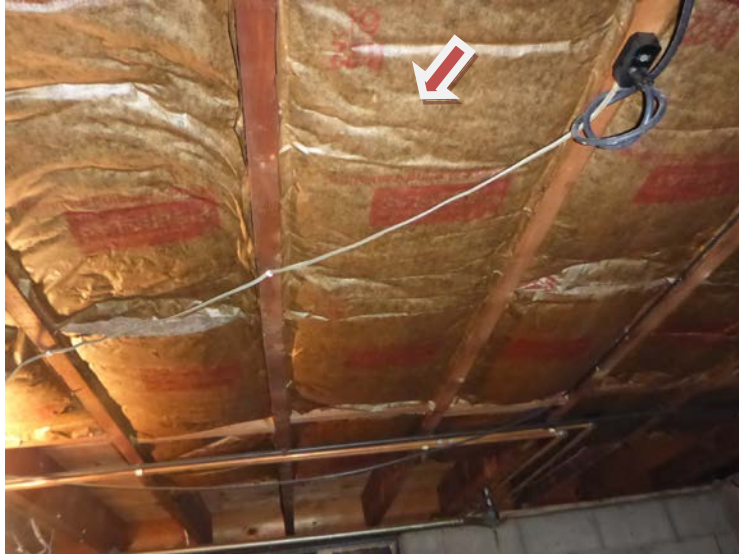
433. Insulation

Fiberglass batts, present in portion of basement only. Vapor barrier appears improperly installed.

Suggest repositioning against heated space above and insulating where not present.

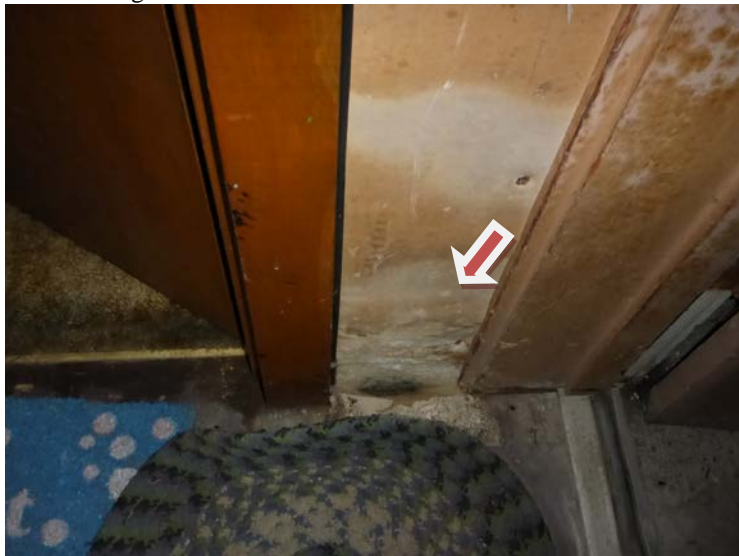
437. Evidence of Water  
Penetration

Yes. Staining noted.

Unable to determine frequency or amount.  
Limited view due to stored items.

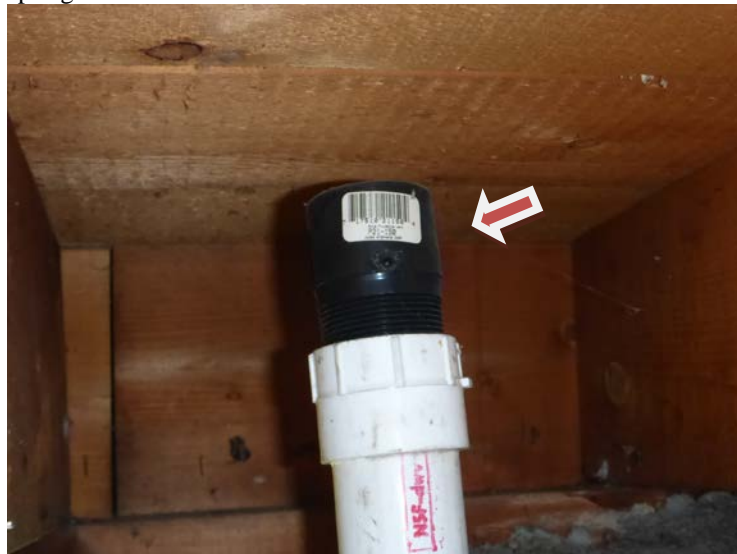
Step #	Component	Comment
601.	Location	Basement right rear.
602.	Cabinets	N
603.	Laundry Sink/Tub	N
604.	Electrical	S
605.	Washer H/U	Spring loaded vent device installed to vent this fixture.

These devices are generally not permitted as they can fail allowing waste gas entry into the area. Suggest installing an approved air admittance valve or extending this vent piping to the exterior by a licensed plumber.

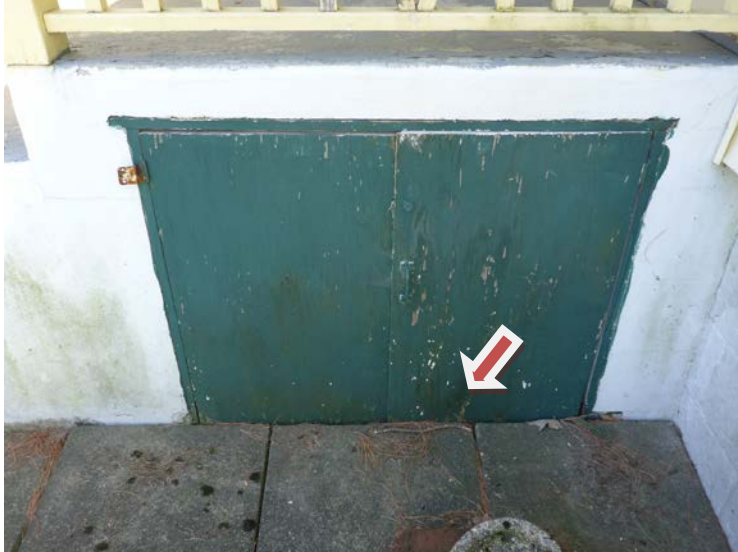
Step #	Component	Comment
451.	Location	Below right side porch.
452.	Access	Unable to open access door to area below right side steps.

Concrete pavers blocking base of access door. Area inaccessible. Concealed issues may exist. Area viewed through window in basement only.
453.	Floor	Inaccessible.
454.	Floor Joists	Inaccessible.
455.	Support Posts/Columns	Inaccessible.
456.	Beams	Inaccessible.
457.	Electrical	Inaccessible.
458.	Ventilation	None present. Suggest consulting a qualified contractor to determine best way to ventilate this area to prevent moisture accumulation and damage.
459.	Insulation	None present/visible.
460.	Vapor Barrier	Inaccessible.
461.	Plumbing	Inaccessible.
462.	Comments	None.

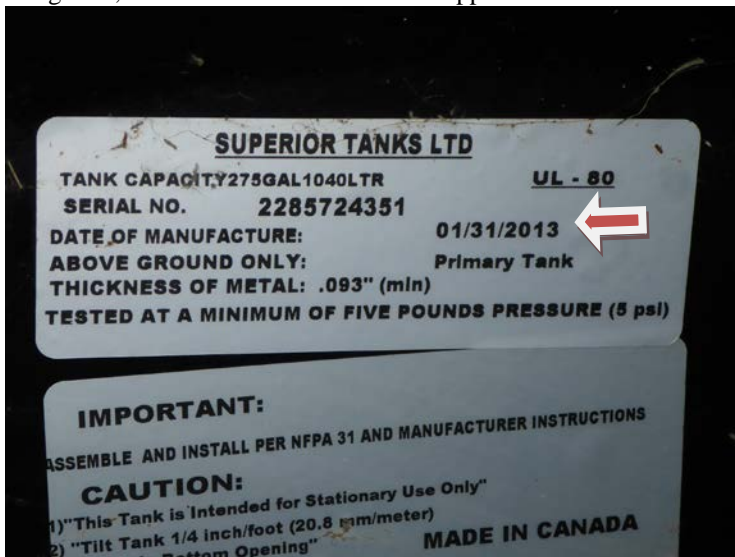
902.	Fuel source	Oil.
903.	Oil tank	275 gallon, located at basement. Oil tank appears installed in 2013.

904.	Heating Conditions	Suggest confirming presence/location of previous tank and, if underground, confirming condition and/or removal. Unable to determine age of boiler. Unit old and may be approaching the end of its useful life. Client should anticipate replacement. Area housing heating system may not be large enough to adequately supply combustion air. Suggest confirming/repair/adjusting as needed by a qualified heating contractor.

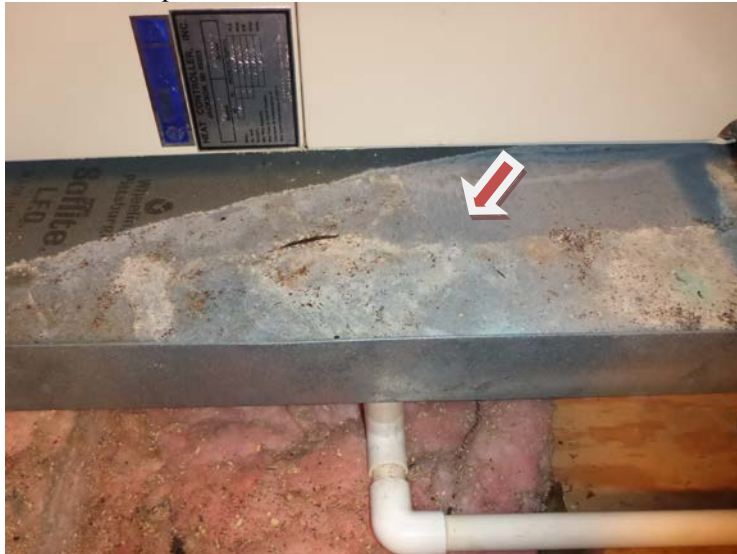
Step #	Component Type	Comment
951.	Type	Compressor/condenser located at exterior rear. Electrical disconnect provided near this unit.
952.	Temperature Differentials	Supply air temperature: 65 degrees. Return air temperature: 78 degrees. Temperature difference was NOT WITHIN the 15 to 22 degree normal operating range at time of inspection. Suggest confirming reason/repair as needed by a qualified, licensed HVAC contractor.
953.	Conditions	Condensate leakage likely sometime in the past into overflow panel below attic evaporator unit.

954.	Comments	Suggest monitoring/repair as needed. Primary and secondary condensate drain lines connected together.
------	----------	--

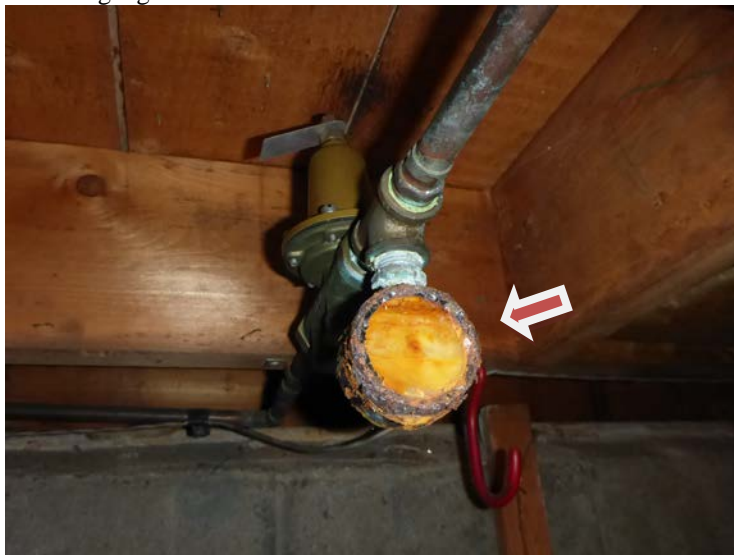
Step #	Component	Comment
1001.	Supply System	Water supply provided by public system. Main shut off located adjacent to water meter at basement right front. Supply piping, where visible, is copper with a copper main.
1002.	Supply Comments	Pressure gauge at basement front corroded.

Suggest replacing. Portions of basement piping not well supported. Unable to view supply piping in basement where walls/ceilings are finished.
1003.	Waste System	Property was reported to be connected to the public sewer system. Client may wish to confirm sewer connection with the local building department or the property owner prior to closing. Waste piping, where visible, is cast iron and plastic.

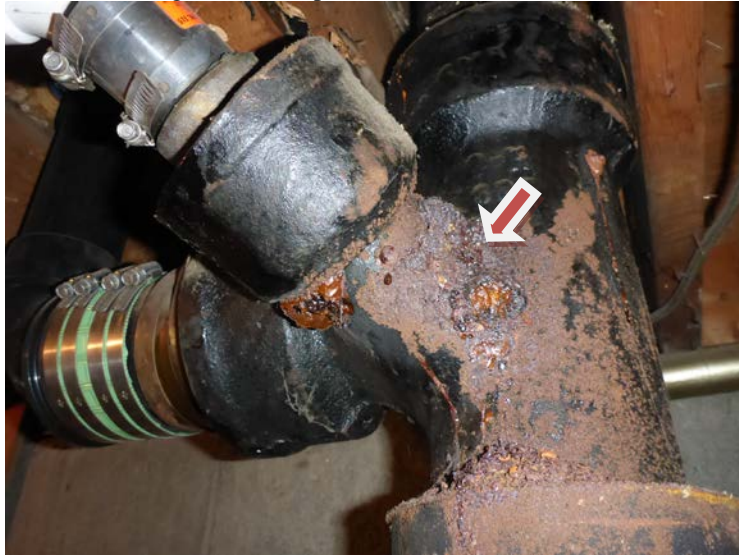
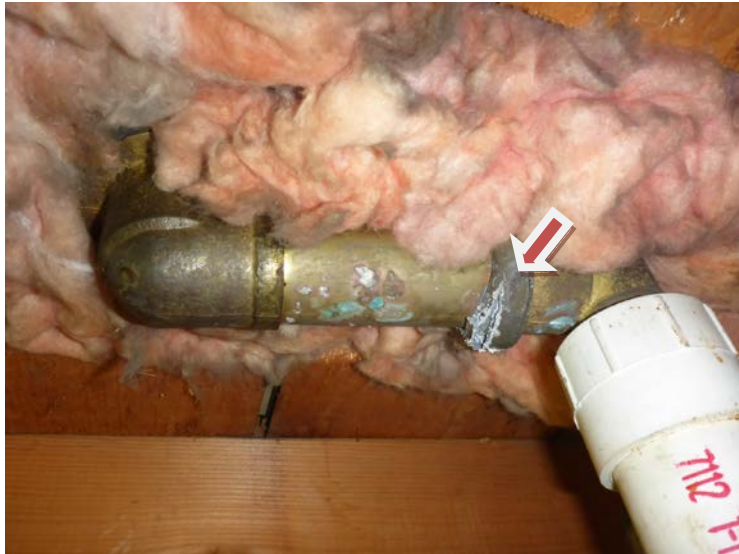
1004. Waste Comments Corrosion/leakage evident at portions of basement drain lines.

Suggest review/repair as needed by a licensed plumber.

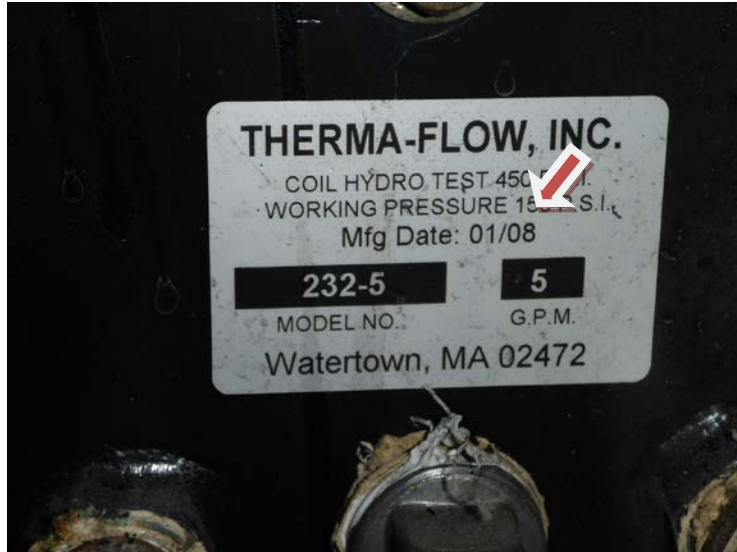
Step #	Component	Comment
1051.	Water Heater	Internal tankless coil. Two present inside boiler. One appears installed in 2007, one in 2008.

1052.	Venting	Client should anticipate replacement. We do not warrant the amount of hot water tankless coils will provide. With age, these coils can corrode and become restricted. N
-------	---------	--

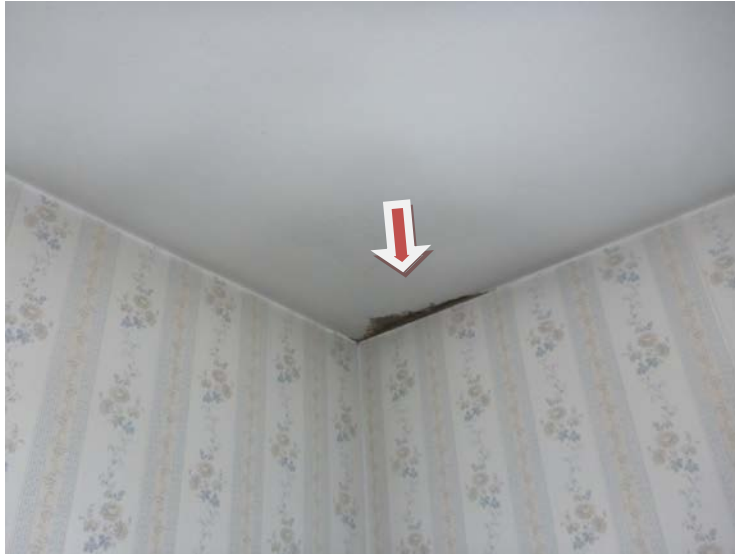
<b>Step #</b>	<b>Component</b>	<b>Comment</b>
3201.	Location	Rear.
3202.	Floor	Carpeted.
3203.	Walls	Plaster and/or gypsum board.
3204.	Ceiling	Plaster and/or gypsum board. Stains noted.

Unable to determine cause or if active. Suggest confirming/repair as needed.
3205.	Doors	S
3206.	Windows	Double hung.
3207.	Electrical	S
3208.	Fireplace	N
3209.	Heat/Cooling Source	Baseboard heat source and forced air register present.
3210.	Closet	S
3211.	Comments	None.
