UNITED INSPECTION SERVICE
CONFIDENTIAL HOME INSPECTION FOR:

Client: Theresa Bechet
email: theresabeaudoin@yahoo.com
Date: August 12, 2016

Street Address: 164 W Bacon St
City / Town: Plainville, MA 02762
Weather: 90's Cloudy/Thunderstorm
Inspection Start Time: 3:45 PM
Inspection Stop Time: 6:00 PM

INSPECTOR: John Mushinsky

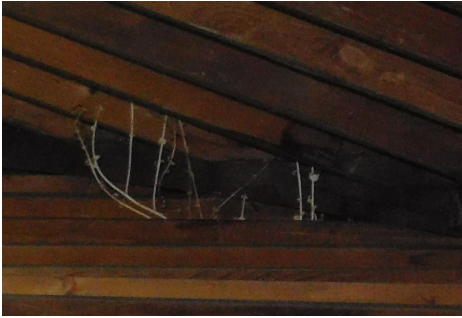
</div> <p>The back section of the attic has significant organic growth present, tree/vine. High moisture is required for a long period of time for a growth this size. Additional Investigation Required to determine presence/absence of concealed damage and/or mold.</p> <p>Anticipate the risk of deteriorating conditions with deferred maintenance/repair.</p> <p>Poor/insufficient lighting in attic.</p>

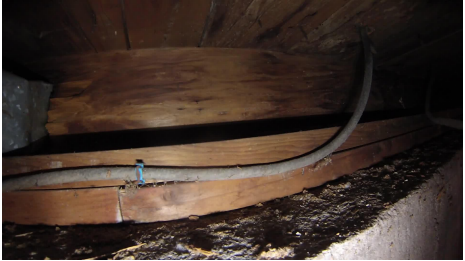
<p>Most sub floor areas not observable.</p> <p>Sub floor is water stained in several areas. The section between the furnace and oil tank is damaged/deteriorated. Additional Investigation Required to determine presence/absence of concealed damage.</p> <p>Unsealed penetrations through the sub floor around pipes/wires. Suspect insufficient fire protection. SAFETY HAZARD.</p>
<u>Columns / Posts</u>			X		<u>Column/Post Material: Filled Metal Columns</u>
<u>Ceiling Insulation</u>	X				<u>Ceiling Insulation Not Present</u>
<u>Crawl Space Ventilation</u>	X				<u>No crawl spaces</u>
Sump Pump			YES		MA Home Inspectors are prohibited from activating sump pumps. Recommend researching the age and condition of the sump pump with the seller.

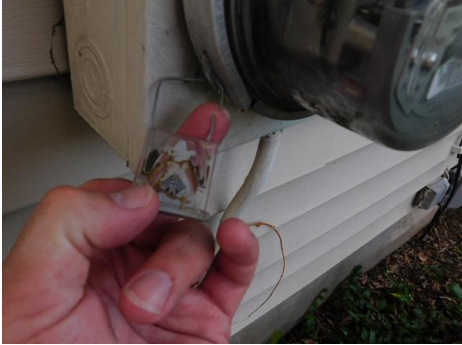
<p>Cut anti-tamper tag at electric meter. Suspect electrical repair/alteration in progress. Recommend researching permits and inspections for electrical repairs/alterations with the seller and Town building officials. Recommend the seller demonstrate an intact tamper tag from the power company.</p>
<u>Grounding System</u>				X	<p><u>Dwelling Electrical Ground: City/Town water pipe</u> <u>Dwelling water pipe ground bond: Yes</u></p>

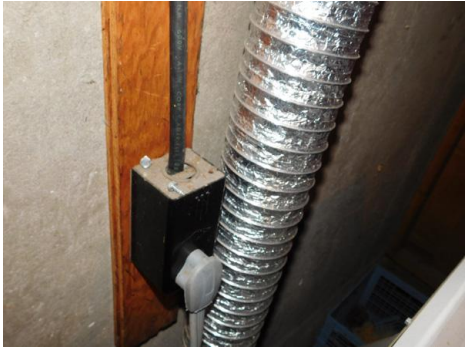
<p>3-wire 240v circuit to dryer. Outdated electrical safety standard. Anticipate requirement to upgrade to 4-wire 240v circuit at time of purchase or installation of a new electric dryer.</p>		
Gas Dryer Fuel Line	X				N/A – Not Present.		
Inspector Comments	<p>Appliances not operated for performance. Recommend transferring remaining appliance warranty. If there is no warranty then the appliance is fully depreciated.</p> <p>Recommend checking all appliances for safety recalls. Search for products on the Consumer Products Safety Commission website http://www.cpsc.gov/en/Recalls/</p>
